# Service Bulletin

Bulletin No.: PI1041A

**Subject:** Information on Water Pump Replacement

**Models:** 2013-2014 Buick Encore Equipped with Engine RPO LUJ, LUV  
2014 Cadillac ELR Equipped with Engine RPO LUU  
2011-2014 Chevrolet Cruze Equipped with Engine RPO LUJ, LUV  
2011-2014 Chevrolet Volt Equipped with Engine RPO LUU  
2012-2014 Chevrolet Sonic Equipped with Engine RPO LUJ, LUV  
2013-2014 Chevrolet Trax Equipped with Engine RPO LUJ, LUV

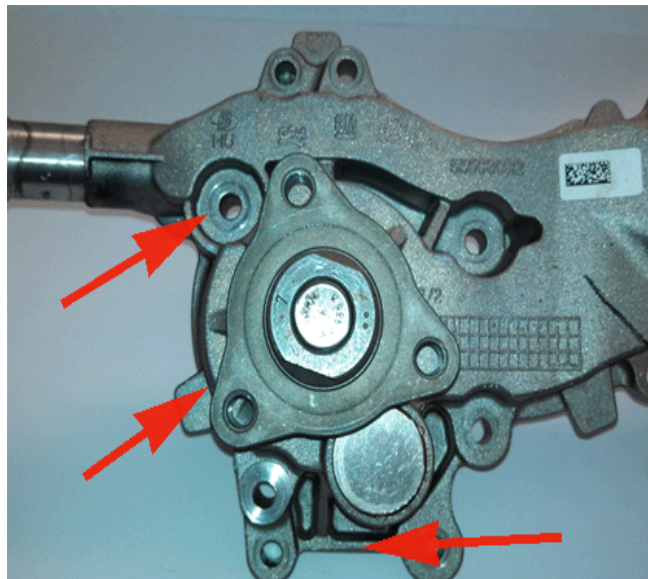
3609232

If the water pump housing shows minimal coolant deposits as shown below, do not replace the pump. The water pump is functioning as designed.

- No evidence of coolant leakage on the pump body.

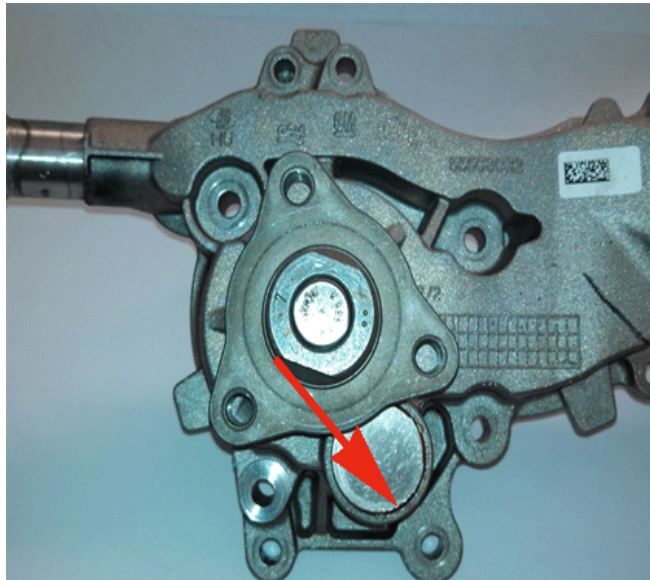
3609233

- Slight coolant staining around the perimeter of the cover plate.

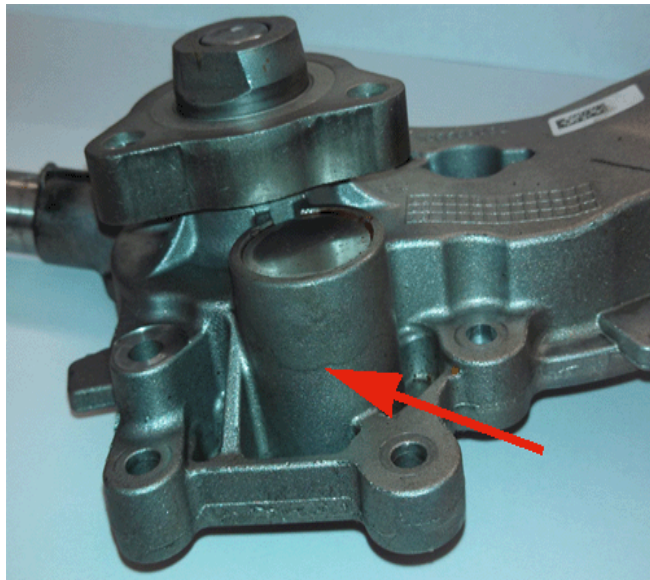
3609237

- Slight coolant staining on the underside of the housing.

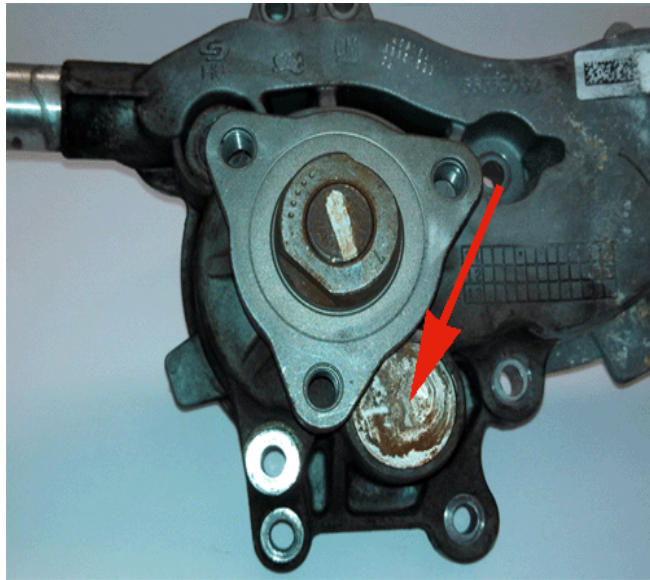
3609253

- Significant coolant residue on the cover plate.

If the pump housing displays excessive evidence of leaking as shown below, replace the pump. Refer to Water Pump Replacement in SI.

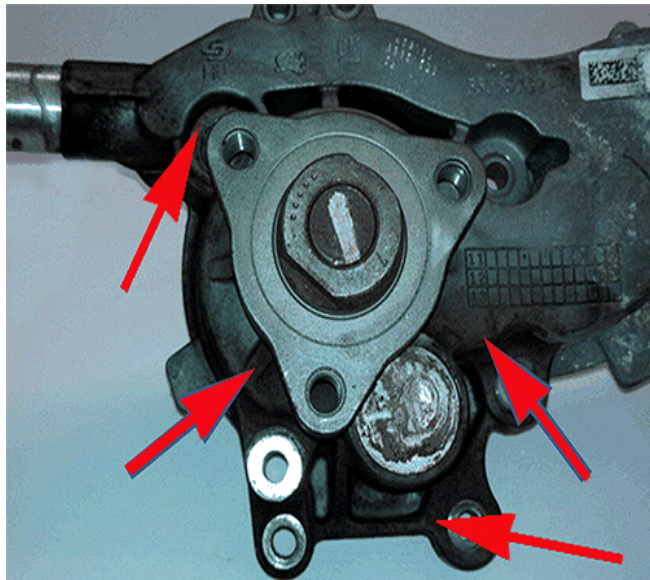
3610640

- Evidence of coolant residue on the exterior surfaces of the pump housing.
