Service Bulletin

File in Section: -Bulletin No.: PI1068 Date: September, 2013

- Subject: DIC Activated Maintenance Service Menu May Not Be Synchronized with Oil Life Monitor (North American Market Only)
- Models: 2014 Buick LaCrosse, Regal 2014 Cadillac ATS, CTS, ELR, SRX, XTS 2014 Chevrolet Corvette, Silverado 1500 2014 GMC Sierra 1500

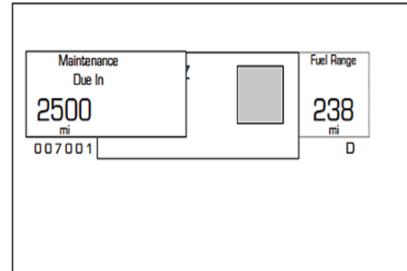
6.2.35~MY14 SERVICE PAGE

Certain 2014 vehicles have been released with IPC/cluster software that has the ability to display a service maintenance menu. This menu is currently turned off in all vehicles as delivered, but has the ability to be activated by the customer in the DIC setting menu. If activated, it will count down from 7,500 miles (12,000 km) and tell the user to go to the dealer when it approaches 0 miles/km. This information may conflict with the oil life monitor and may cause confusion among customers as to which service screen is correct.

Distance Until Maintenance Value

The service page is intended to aid the driver with scheduled maintenance for their vehicle. The amount of miles left before maintenance is shown in mile or km units in increments of 7500mi/12,000km. When the countdown reaches 0, it remains at 0 until the value is reset.

Distance Until Maintenance Resettable Using Select If the user preforms an EXTRA LONG press-and-hold on the SELECT button, the distance until maintenance is reset to 7500 miles/12,000km.

Distance Until Maintenance Reset on Cluster Replaced The distance until maintenance is reset when the cluster is replaced.

Distance Until Maintenance available to OnStar The distance until maintenance value should be made available to the OnStar module. Data should include remaining miles until service, value that triggers the aler and whether or not the alert is active.

If a customer comes in with the service menu activated, has questions about the menu or is confused to what it is used for, the technician may calibrate off the menu through SPS and indicate to the customer that it mimics or is a duplicate of the Oil Life Monitor and has been eliminated to prevent any future confusion.

Important: DO NOT replace the instrument cluster for this condition.
