# Service Bulletin

Bulletin No.: P11090

**Subject:** Wet Carpet/Floor at Driver and/or Passenger Footwell Areas

**Models:** 2010-2014 Chevrolet Equinox  
2010-2014 GMC Terrain

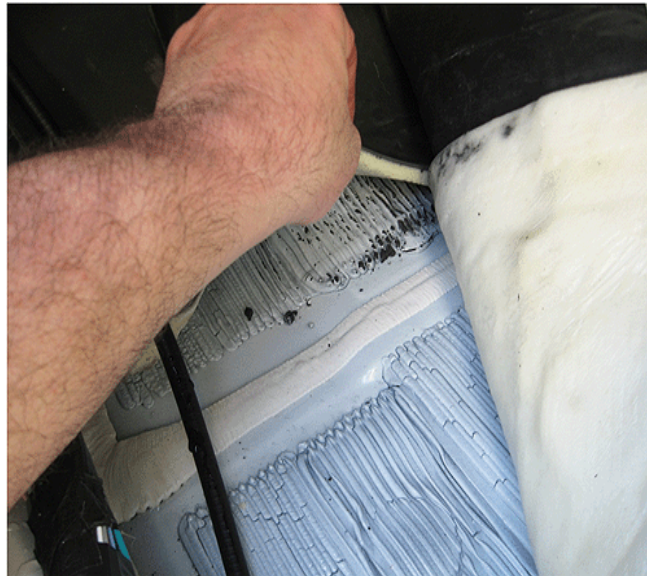
2450865

This condition may occur due to incomplete or insufficient sealing within the front roof to body side outer panel seams. The condition is most commonly found in the roof ditch within the first 30.5 cm (12 in) rearward from the windshield glass.

If evidence of water is found in these locations, inspect the affected side roof ditch for possible voids in the sealer. Inspect for, and correct this leak, following the repair steps below:

1. On the side(s) affected, carefully remove the forward portion of the roof ditch molding; enough to access the first 30.5 cm (12 in) of the roof ditch. Refer to Roof Panel Molding Replacement in SI.
