Bulletin No.: PIC5428D

Service Bulletin

Subject: EBCM Wheel Speed Sensor Diagnostic Aid for ABS Message - Click Or Ratchet Noise - Service Traction Message - Service StabiliTrak Message

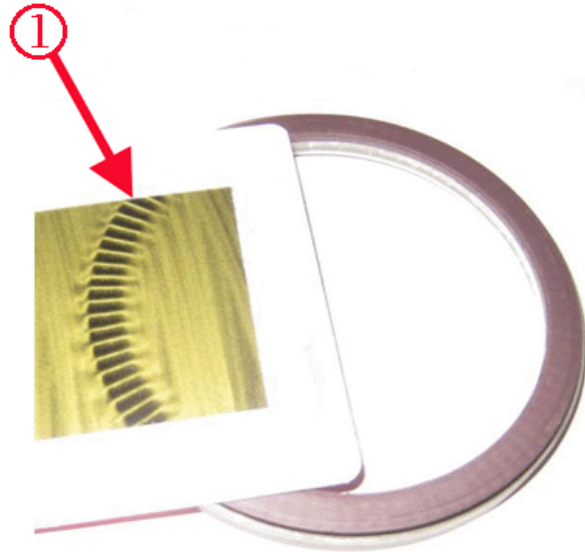
2596034

1. Wheel Speed Sensor Magnetic Encoder Ring
North and South Poles are shown
NEW BEARING DESIGN

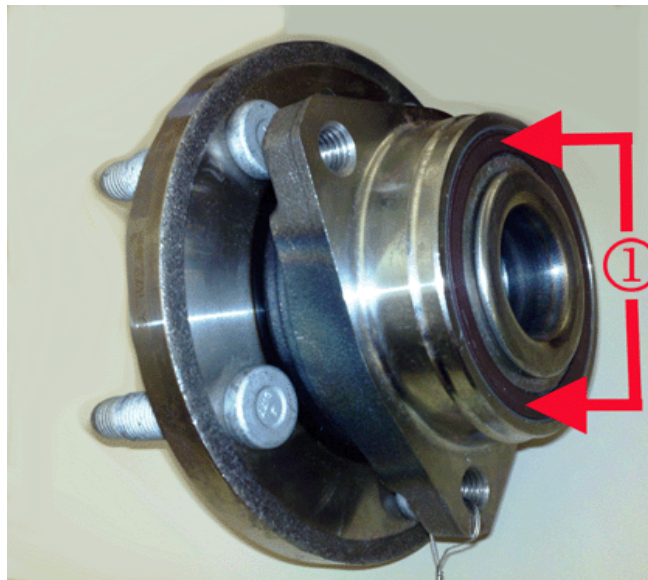
2596032

1. Magnetic Encoder Ring

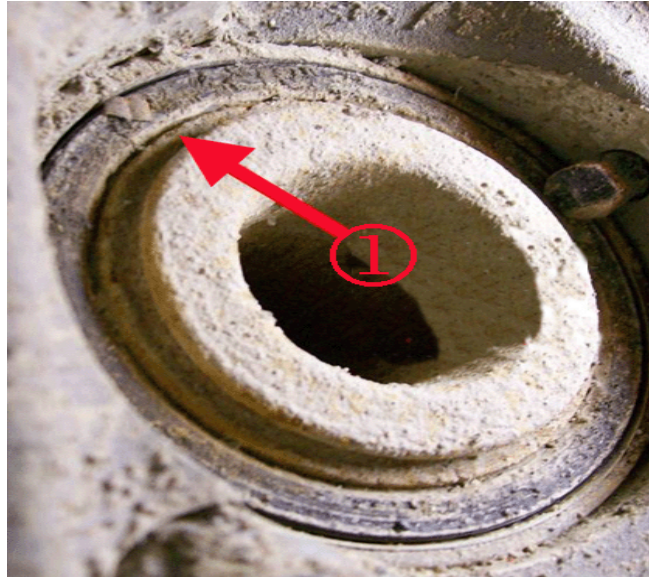
2596037

These conditions may be caused by single or multiple pieces of ferrous metallic debris stuck to the wheel speed sensor magnetic encoder ring. This magnetic encoder ring is now part of the inboard bearing hub assembly.

BEFORE CLEANING

1. Sample Debris

- 2.1. Gently using a dry nylon soft bristle brush, remove the foreign debris off the magnetic encoder ring. If debris was removed, proceed to step 3.
- 2.2. If debris still remains, wash the encoder ring using a mild soap detergent and wipe dry.

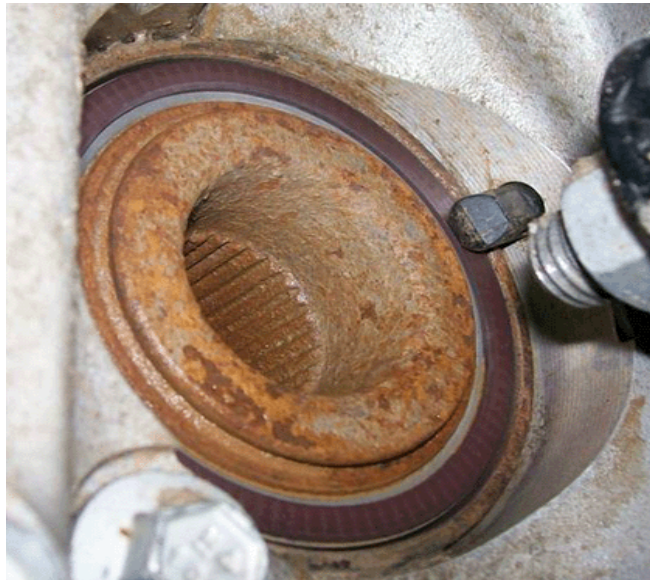
2596035

AFTER CLEANING

3. Connect a scan tool to the vehicle. Turn ON the ignition. Clear the DTCs.
4. Perform vehicle diagnostic repair verification procedure for DTC: C0035-C0050. Refer to SI.
