Service Bulletin

Bulletin No.: PIC5428E

Subject: EBCM Wheel Speed Sensor Diagnostic Aid for ABS Message - Click Or Ratchet Noise - Service Traction Message - Service Stabilitrak Message - Service Steering Message

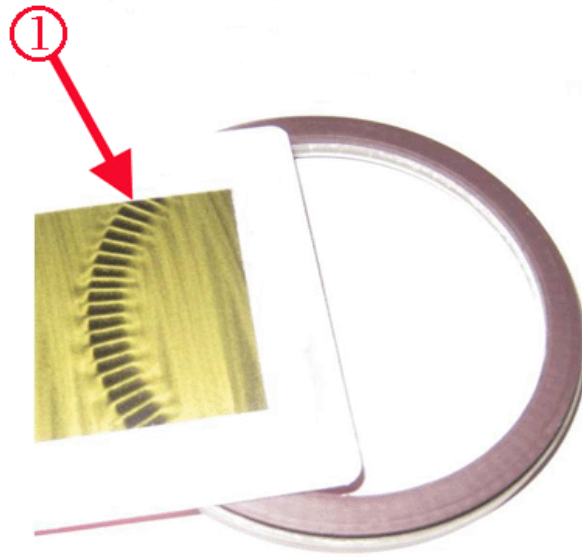
2596034

(1.) Wheel Speed Sensor
Magnetic Encoder Ring - North and South Poles are shown
New Bearing Design:

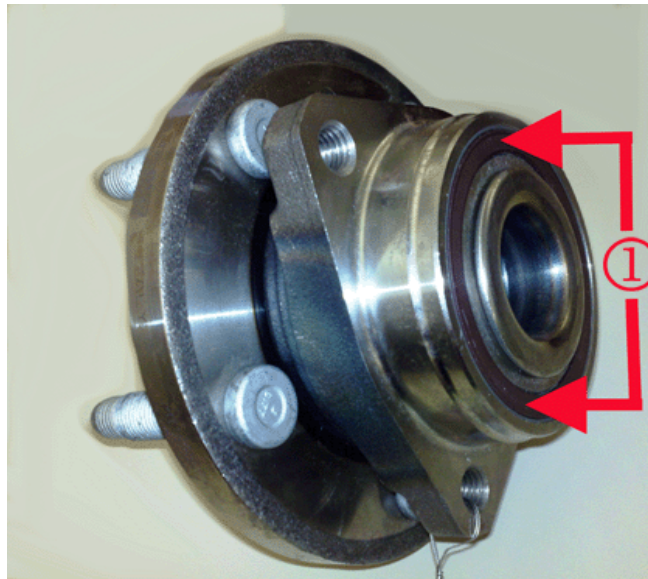
2596032

(1.) Magnetic Encoder Ring

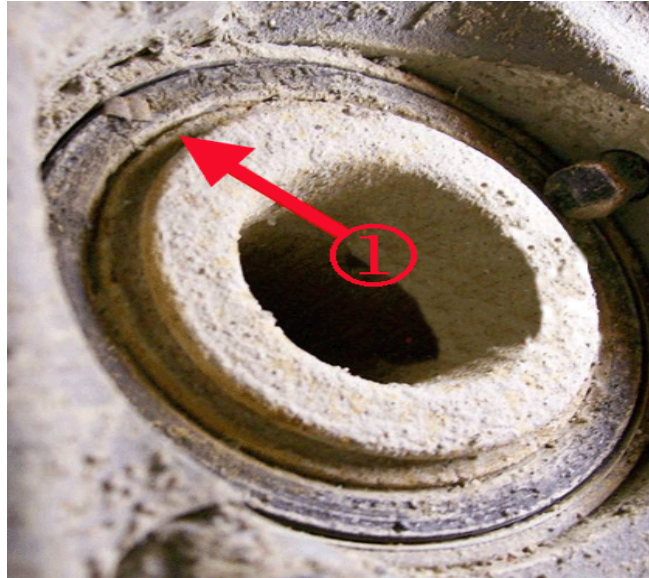
2596037

These conditions may be caused by single or multiple pieces of ferrous metallic debris stuck to the wheel speed sensor magnetic encoder ring. This magnetic encoder ring is now part of the inboard bearing hub assembly.
Background Information:

BEFORE CLEANING

(1.) Sample Debris

- 2.1. Gently using a dry nylon soft bristle brush, remove the foreign debris off the magnetic encoder ring. If debris was removed, proceed to step 3.
- 2.2. If debris still remains, wash the encoder ring using a mild soap detergent and wipe dry.

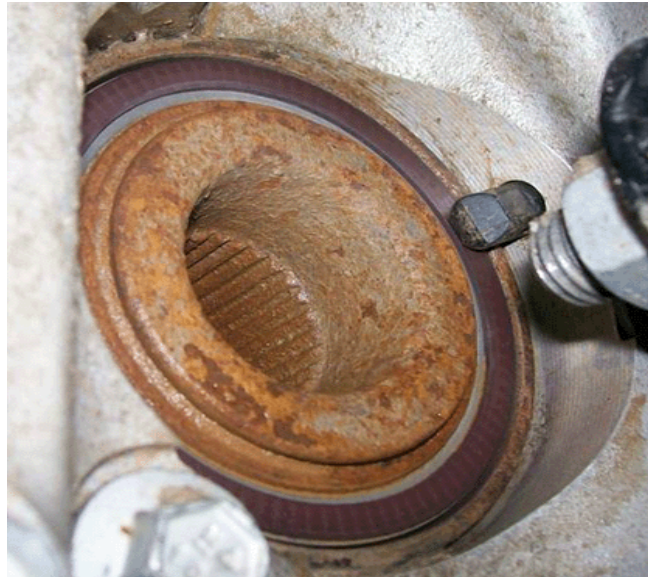
2596035

AFTER CLEANING

1. Connect a scan tool to the vehicle. Turn ON the ignition. Clear the DTCs.
2. Perform vehicle diagnostic repair verification procedure for DTC: C0035-C0050. Refer to SI.
