Service Bulletin

Bulletin No.: PIT4684A

Subject: Rear Camera Display Blank

Models: 2009 - 2013 Cadillac Escalade Models
2009 - 2013 Chevrolet Suburban, Tahoe
2009 - 2013 GMC Yukon, Yukon Denali, Yukon XL, Yukon Denali XL
With RPO UVC Rear Camera

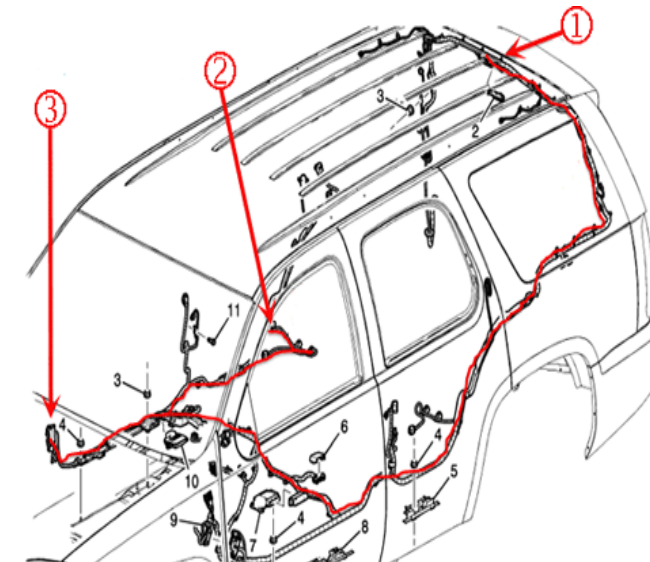
1. X413
2. X421/X322
3. X209

Some customers may comment on a condition with the rear camera display being inoperative when shifting into reverse. This concern could be caused by an open or shorted camera circuit (7641, 7642, and 6799) between the camera and display (Navigation Radio or ISRVM). To help understand the body harness routing of the rear camera circuits, see the picture below. Starting at the liftgate, X413 connects the liftgate harness to the body harness. The body harness runs along the rear of the roof to the driver's side "D" pillar and then down and along the driver's side to the door sill. At the driver's seat, the harness routes across the truck (going under the driver's seat, center console/center seat and passenger seat) to the passenger sill. At the passenger sill, the circuits will either go forward to X209, if equipped with a Navigation Radio, or rearward to X421/X322, if equipped with display in the ISRVM.
