Service Bulletin

Bulletin No.: PIT5180

Subject: Whistle Noise From Drivers Side A Pillar Area (Inspect VIN Plate Rivets)

Models: 2008-2013 Cadillac Escalade Models
2008-2013 Chevrolet Avalanche, Silverado, Suburban, Tahoe
2008-2013 GMC Sierra, Yukon Models

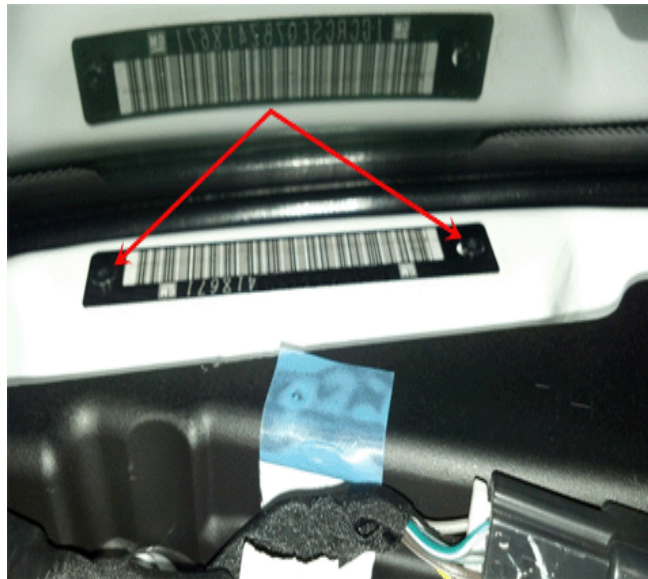
2910666

Some owners may comment of a whistle noise coming from the driver's side "A" pillar area when driving around 50 mph with the HVAC in recirculation mode. This whistle noise may be coming from one of the rivets securing the VIN plate to the cowl (see picture below). It may be hard to pin point the source of the noise, but the use of a stethoscope or the Ultrasonic Leak Detector (J-41416) may be helpful.

Reseal the rivet(s) using RTV sealer from the underside. The underside of the rivet can be accessed through the cowl.
