# Service Bulletin

Bulletin No.: PIP5065

**Subject:** Ticking Noise in 3rd and 4th Gear Above 30 MPH.

**Models:** 2010-2012 Chevrolet Colorado  
2010-2013 Chevrolet Express, Silverado  
2010-2012 GMC Canyon  
2010-2013 GMC Savana, Sierra

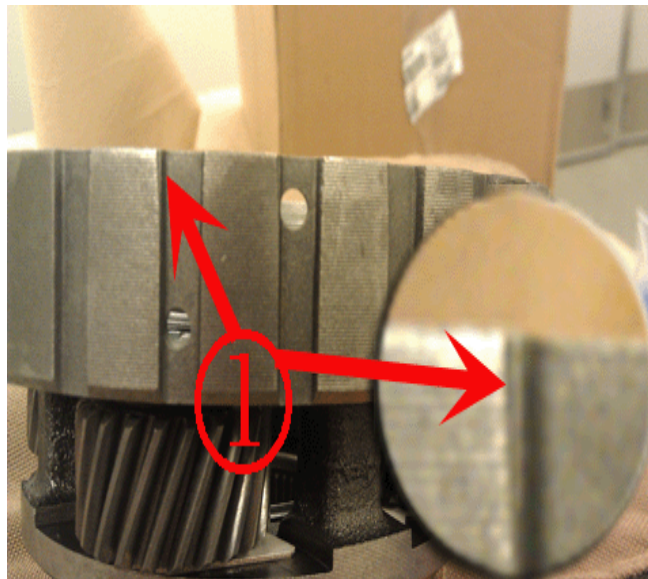
2914493

### Call out 1

Shows a taper in the machined surface of the reaction carrier lug.

This mis-machined hub is causing the low reverse clutch plates to stick and release creating the ticking noise

Replace the Reaction Carrier and low reverse clutch plates.
