Service Bulletin

Bulletin No.: 15-NA-084

Subject: Diagnostic Tips for Engine Running Rough, Poor Acceleration, Smell of Exhaust Inside Cabin, Possible P0101, P0299, P2002, P2263 or P2463 DTCs Set

Brand:	Model:	Model Year:		VIN:		Engine:	Transmission:
		from	to	from	to		
Chevrolet	Cruze	2014	2015			2.0L Diesel Engine (RPO LUZ)	All

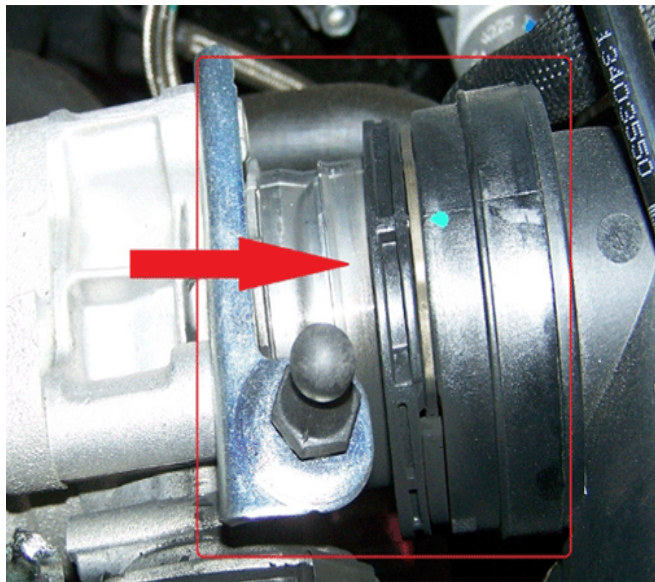
4335262

Visually inspect to see if the charge air cooler (CAC) duct has become disconnected from the throttle body.

If the charge air cooler duct has become disengaged, complete the following:

- Replace the charge air cooler duct with a new one. Refer to the proper replacement procedure in SI.

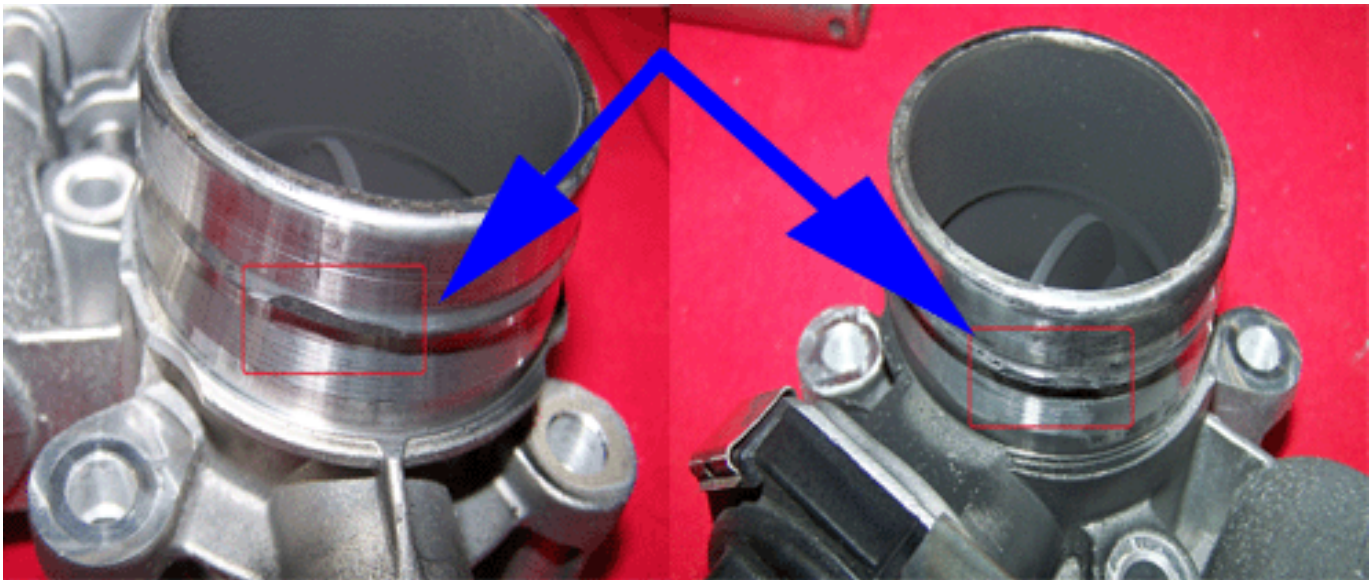
4335267

- Visually inspect for throttle body damage.
