**HYUNDAI**NEW THINKING.
NEW POSSIBILITIES.**Technical Service Bulletin**

16-01-007

SONATA (YF)**SUBJECT:** SONATA (YF) BRAKE PEDAL STOPPER REPLACEMENT
(RECALL CAMPAIGN 136)***THIS TSB SUPERSEDES 15-01-056 TO INCLUDE A STEP TO SET THE STOP LAMP SWITCH GAP ACCORDING TO SPECIFICATION.*****★ IMPORTANT******* Retail Vehicles *****

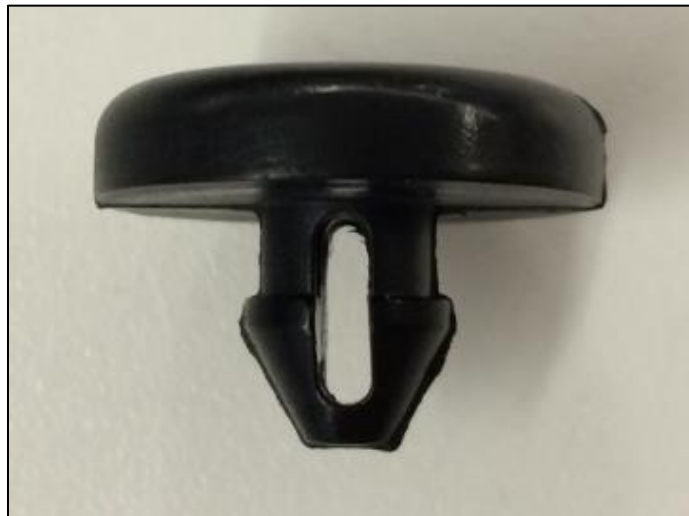
Description: The brake pedal stopper pad is located between the stop lamp switch and the brake pedal arm. The brake pedal stopper pad material in the affected vehicles can deteriorate allowing the stop lamp switch plunger to remain extended when the brake pedal is released. A deteriorated pad can result in the stop lamps illuminating continuously, illumination of the traction control warning lamp, the ability to move the shift lever without depressing the brake pedal, or activation of the engine management system's brake pedal override feature.

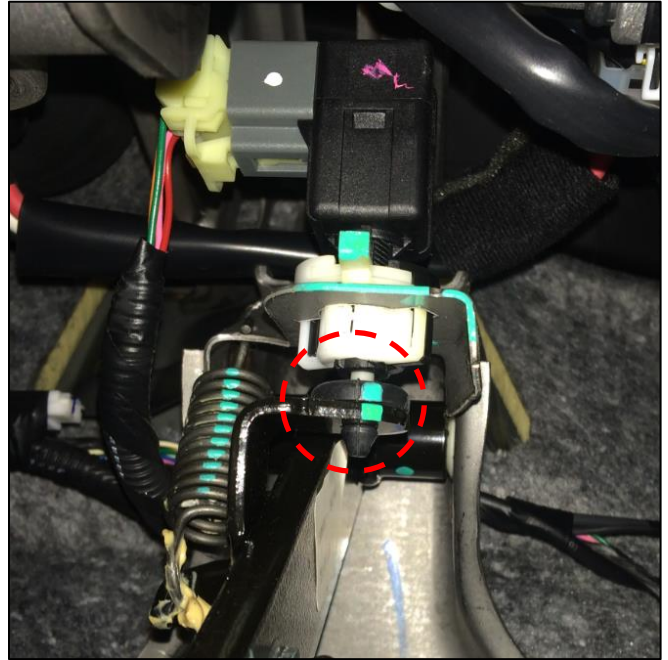
3. The stopper is mounted on the brake pedal, in-line with the stop lamp switch.
