Technical Service Bulletin

16-01-011-1

Elantra (MD/UD)

SUBJECT: YAW RATE/"G" SENSOR INSPECTION AND HECU UPDATE
(RECALL CAMPAIGN 137)

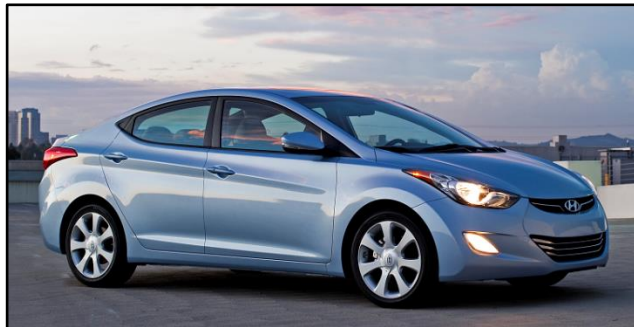
On certain 2011 to 2012 model year Elantras (MD/UD), the Yaw Rate/"G" sensor may send a signal that may result in one or more of the following:

1. Inadvertent ESC system intervention,
2. Illumination of the "ESC" indicator lamp in the instrument cluster.
3. Diagnostic codes C1282 and/or C1283 (for the yaw sensor) stored in the ESC Control Module.

ESC system intervention may include inadvertent brake application to one or more wheels and/or reduced engine torque, both of which can increase the risk of a crash. This bulletin describes the procedure to check for diagnostic codes, replace the Yaw/"G" sensor if necessary, and update the hydraulic unit ECU (HECU) software.

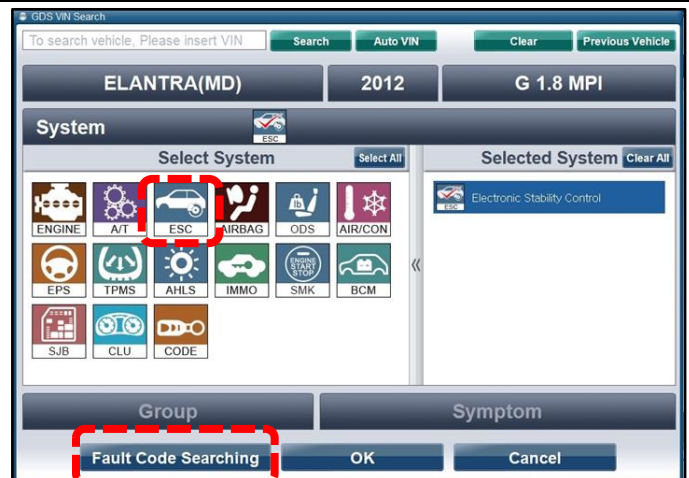
- 2a. If codes **C1282** or **C1283** are found either as active or history;
1. Attach a GDS screen capture of the Fault Code Search screen, clearly showing the VIN and the C1282 and/or C1283 DTCs found.

1. Connect the GDS or GDS Mobile and search for DTCs in the ESC System.
