Service Bulletin

Bulletin No.: PI0850A

Subject: Whistle Noise Heard from Engine Compartment, Rough Idle and/or DTC P0171 Set

Models: 2011-2012 Chevrolet Cruze
Equipped with 1.4L Engine (RPO LUJ)

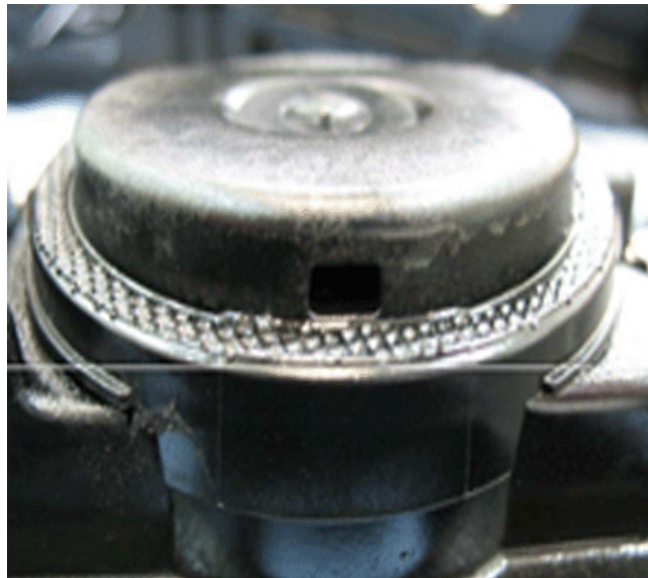
2911929

Note: The old style camshaft cover has a taller design PCV cap as shown in the illustration above.

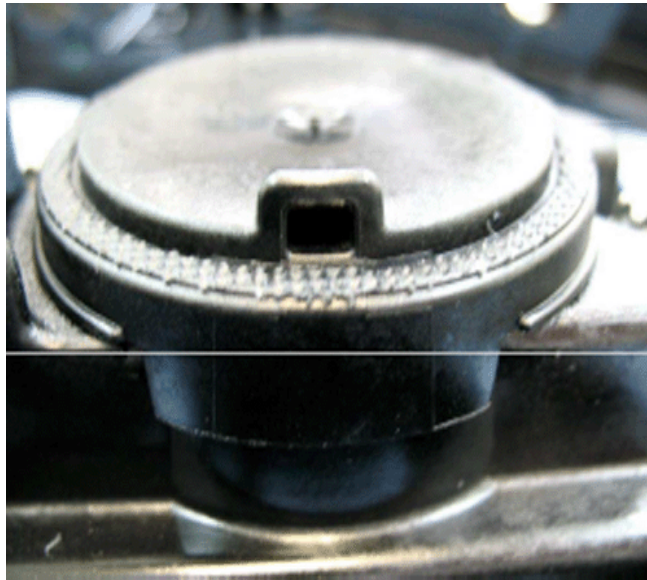
2911935

Note: The new design camshaft cover has a flatter/lower cap as shown in the illustration above.
