# Program Bulletin

## CUSTOMER SATISFACTION PROGRAM

**SUBJECT:** SiriusXM Travel Link Feature Availability

**MODELS:** 2013 Buick Encore, LaCrosse, Regal, Verano  
2013 Chevrolet Camaro, Cruze, Equinox, Malibu, Volt  
2013 GMC Terrain  
Equipped with Panasonic Color Navigation and Color Connected Radios  
(RPO UHQ or UFU & UP9)

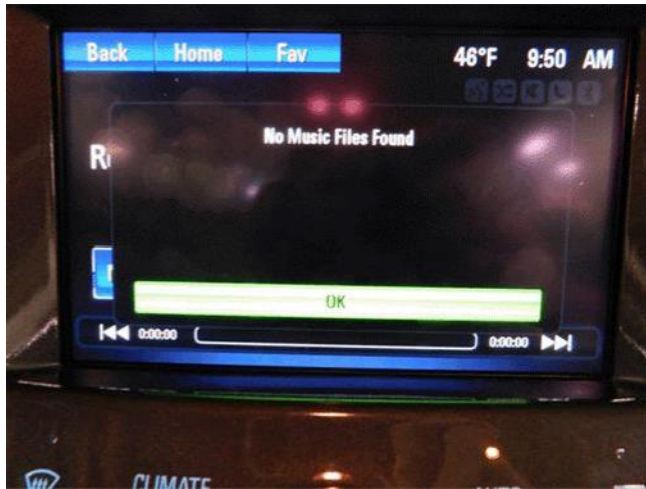
4341290

10. A No Music Files Found message will appear on the screen. Press OK to dismiss the message.
