AT15-006b

ITB15-011b

April 5, 2016

2013 JX35 AND 2014-2015 QX60; ENHANCED DIAGNOSTIC LOGIC FOR CVT JUDDER

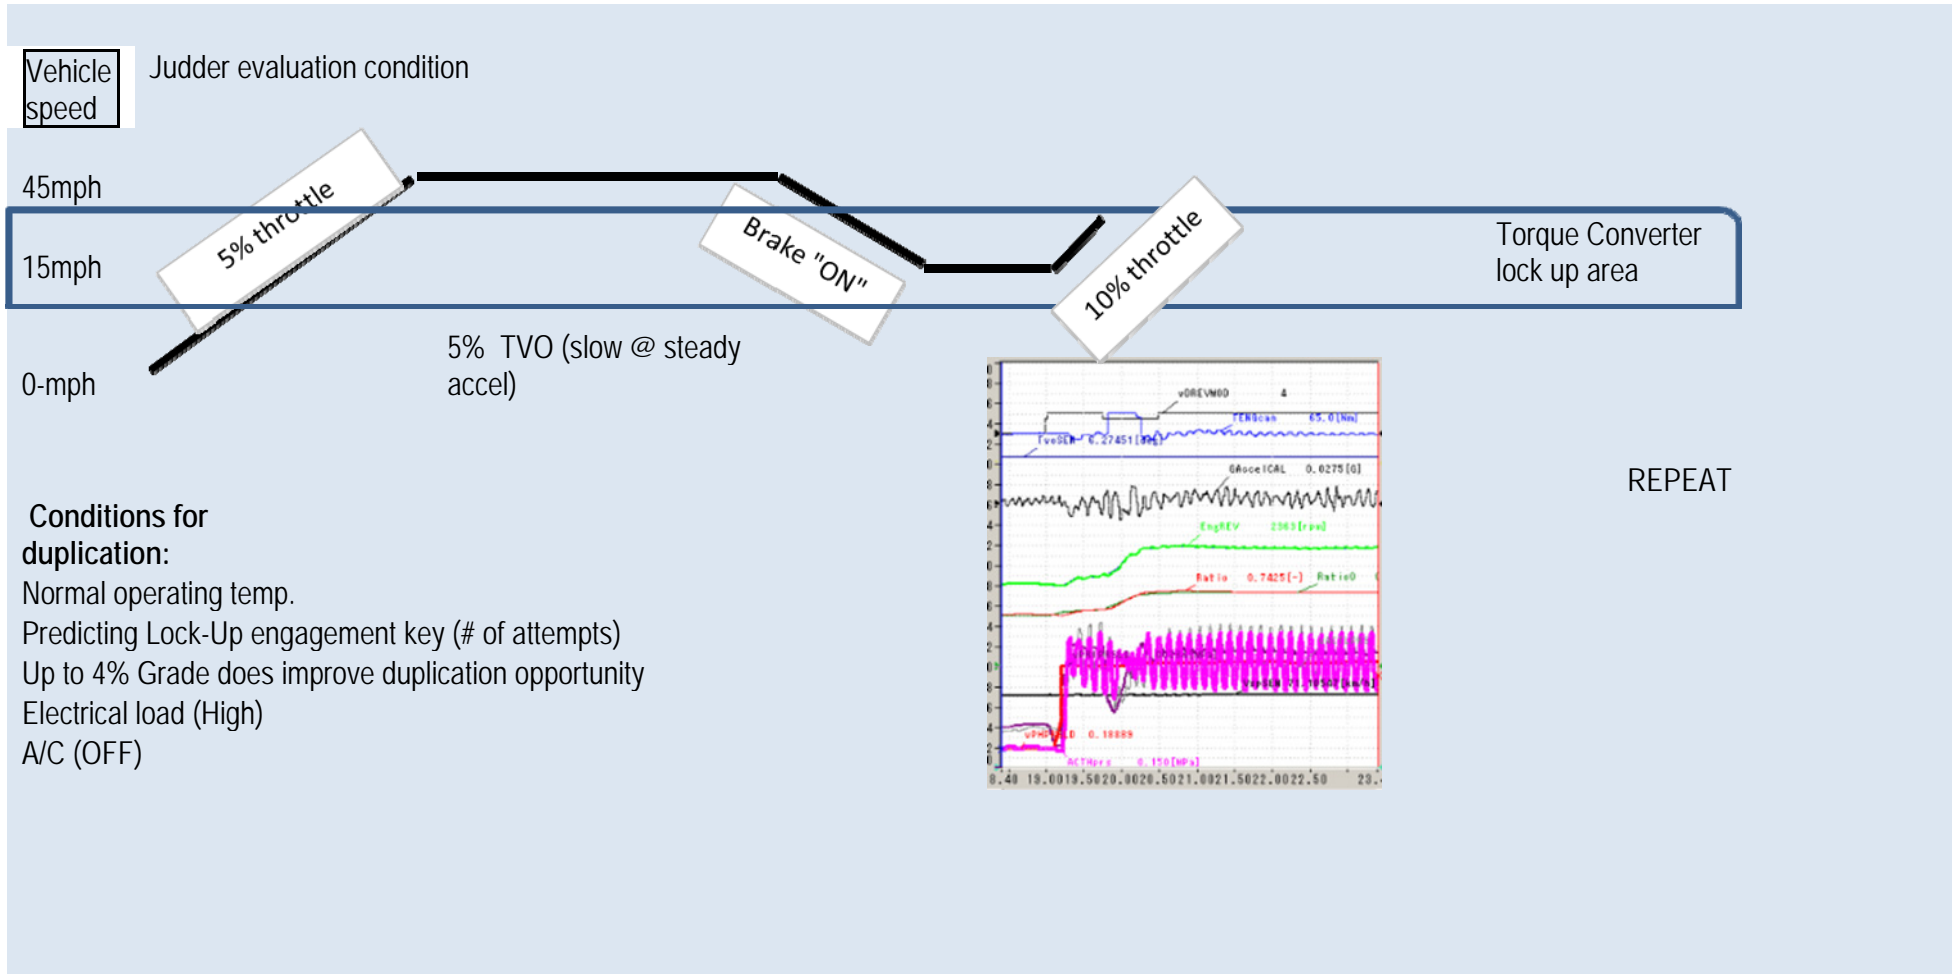
DTC detection drive pattern for P17F0 / P17F1

- This new diagnostic logic will monitor conditions in the CVT while the customer is operating their vehicle in their usual daily drive patterns.
 - Figure 8, on the next page, illustrate conditions under which judder can be reproduced.
 - Specific drive conditions that can be used to test for judder (shake, shudder, single or multiple bumps or vibration) are:
1. Slowly accelerate from a stop (zero mph), applying only slight accelerator pedal (**0% - 10% throttle opening**) until 40 mph is reached.
 - During acceleration, torque converter engagement (full lock up) can occur between 20-35 mph.
 2. Prior to torque converter lock up, slowly modulate accelerator pedal:
 - A. Decrease accelerator pedal pressure slowly, approaching a closed throttle position.
 - B. Smoothly and slowly reapply accelerator pedal pressure back to approximately 10% throttle opening.

- Figure 8 below illustrates conditions under which judder can be reproduced.

- Slight grade (climbing hill) may aid in performing the above drive conditions.
- DTC detection logic will require three events before storing a DTC.
- If DTC P17F1 or P17F0 is stored, refer to ITB15-012 for repair information.
