EC16-008

ITB16-013

2014-2015 QX60; MIL ON WITH DTC P0116

APPLIED VEHICLES: 2014-2015 QX60 (L50)NOTE: This bulletin does not apply to QX60 Hybrid vehicles

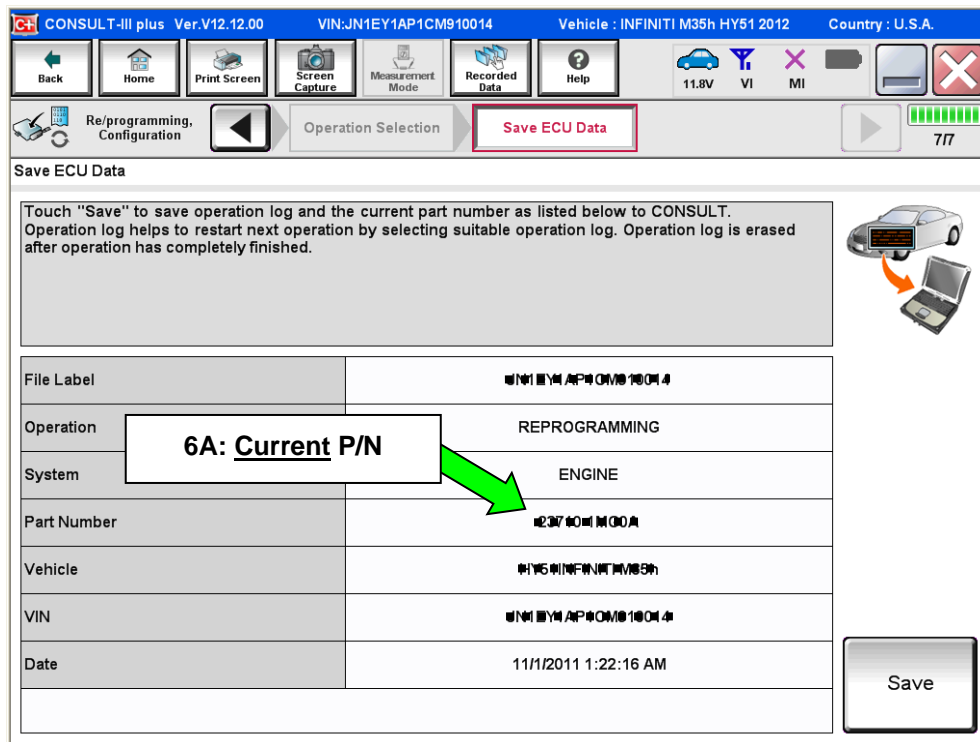
Figure 2

6. When you get to the screen shown in Figure 2, confirm this bulletin applies as follows:

A. Find the ECM Part Number and write it on the repair order.

B. Compare the P/N you wrote down to the numbers in the **CURRENT ECM PART NUMBER** column in **Table A** below.

- If there is a **match**, this bulletin **applies**. Continue with the reprogramming procedure.
- If there is **not a match**, ECM reprogramming **does not apply**. Refer to ASIST for further diagnosis.

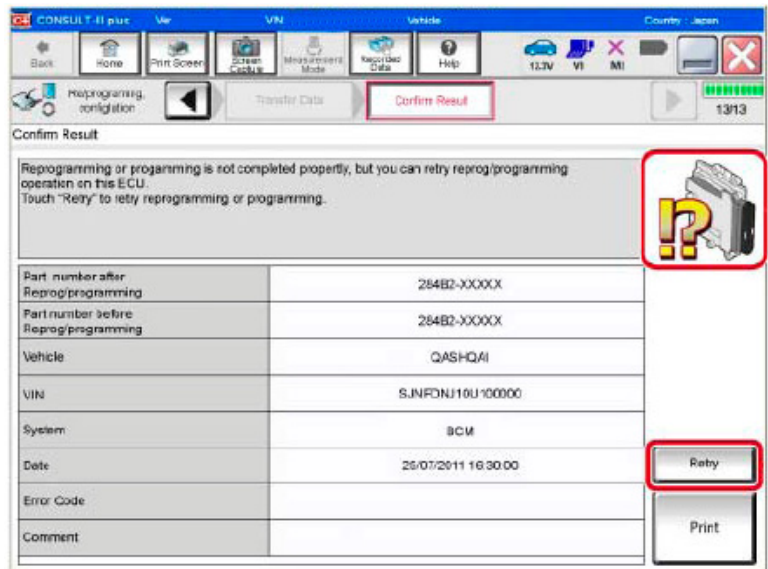
Figure 5

If reprogramming does not complete and the “!” icon displays as shown in Figure 5:

- Check battery voltage (12.0–15.5 V).
- Ignition is ON, engine OFF.
- External Bluetooth® devices are OFF.
- All electrical loads are OFF.
- **Select retry and follow the on screen instructions.**
- “Retry” may not go through on first attempt and can be selected more than once.

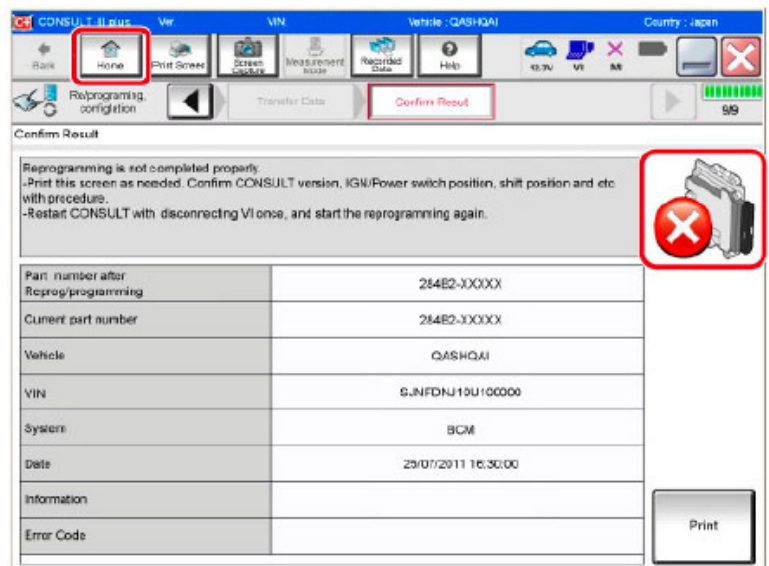
Figure 6

If reprogramming does not complete and the “X” icon displays as shown in Figure 6:

- Check battery voltage (12.0 – 15.5 V).
- CONSULT A/C adapter is plugged in.
- Ignition is ON, engine OFF.
- Transmission is in Park.
- All C-III plus / plus VI cables are securely connected.
- All C-III plus updates are installed.
- **Select Home, and restart the reprogram procedure from the beginning.**
