# Front Exhaust Pipe Catalyst Rattle Noise and/or MIL "ON" DTC P0420

YEAR(S)	MODEL(S)	ADDITIONAL INFORMATION
2010	Tacoma	VDS(s): NX4CN, NX4GN, PX4EN, TX4CN, TX4GN, UX4EN

Some 2010 model year Tacoma vehicles equipped with the 2TR-FE engine may exhibit a front exhaust pipe catalyst rattle noise and/or MIL "ON" condition with DTC P0420 (Catalyst System Efficiency Below Threshold) stored in the Engine Control Module (ECM) (SAE Term: Powertrain Control Module/PCM). Refer to the repair procedure to address this condition.

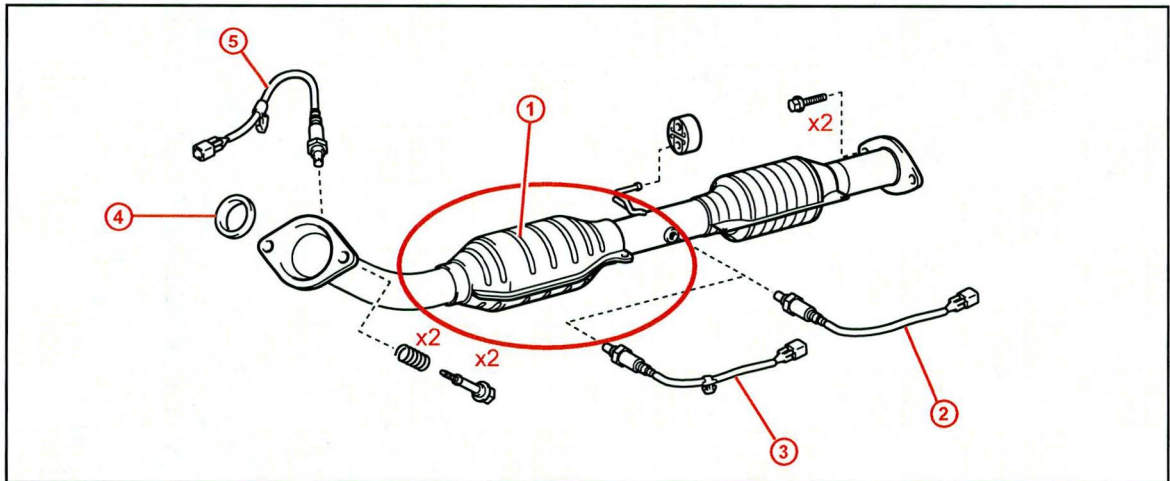
Figure 1. 2TR-FE Front Exhaust Pipe Components

- Increase the engine speed and listen to the catalytic converter section on the front exhaust pipe assembly for a rattle noise.

- Did the noise appear to be the loudest at the catalytic converter section of the front exhaust pipe assembly?
  - YES** — Continue to step 5.
  - NO** — This bulletin does NOT apply. Continue diagnosis using the applicable Repair Manual.
- Replace the front exhaust pipe assembly.

- 2010 Tacoma:  
*Engine/Hybrid Systems – Intake/Exhaust – “2TR-FE Exhaust: Exhaust Pipe: Removal / Installation”*
- Test drive vehicle to confirm repair.
