HYUNDAI NEW THINKING. NEW POSSIBILITIES. Technical Service Bulletin	GROUP CAMPAIGN	NUMBER 16-01-017
	DATE APRIL 2016	MODEL(S) ELANTRA (AD)
SUBJECT: BATTERY TERMINAL AND MOUNTING BRACKET INSPECTION (SERVICE CAMPAIGN TAA)

Applicable Vehicles: Certain 2017 ELANTRA (AD)

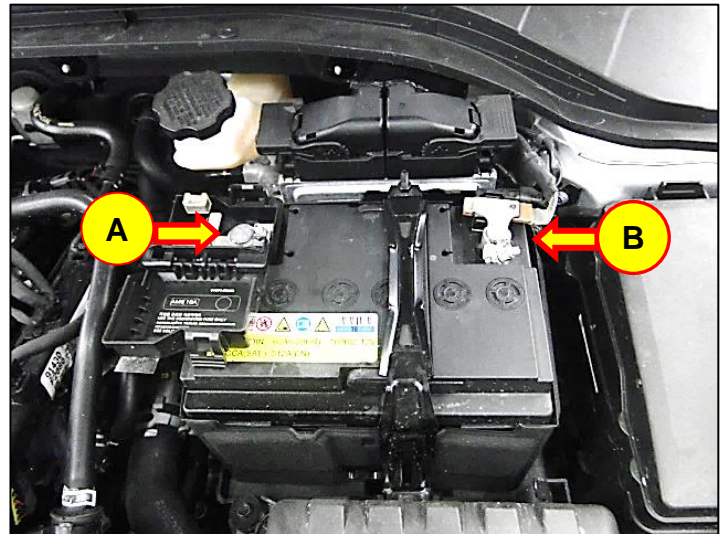
The battery mounting bracket was recently replaced on some 2017MY Elantra vehicles at a port facility. The battery terminals and battery mounting bracket bolts might not have been properly secured during replacement.

1. Open the hood.
2. Verify both battery terminal clamps (A) and (B) are fully seated and securely fastened. Use a 10 mm socket or wrench to verify the clamp torque on each terminal.

Tightening torque: 5.8 ~ 7.2 lb-ft (7.8 ~ 9.8 Nm)
