Service Bulletin

Bulletin No.: 16-NA-130

Subject: No Reverse, No Second After Upper Valve Body Replacement

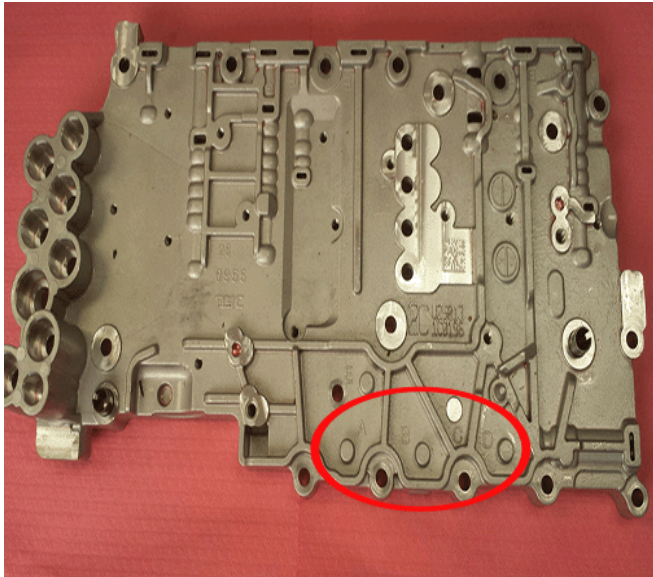
4498528

Location of the four post shown above.

Upper valve bodies are unique by transmission RPO. Each upper valve body has four posts labeled A, B, C and D on the top side of the upper valve body. Inspect the upper valve body as shown below to determine the correct RPO usage.

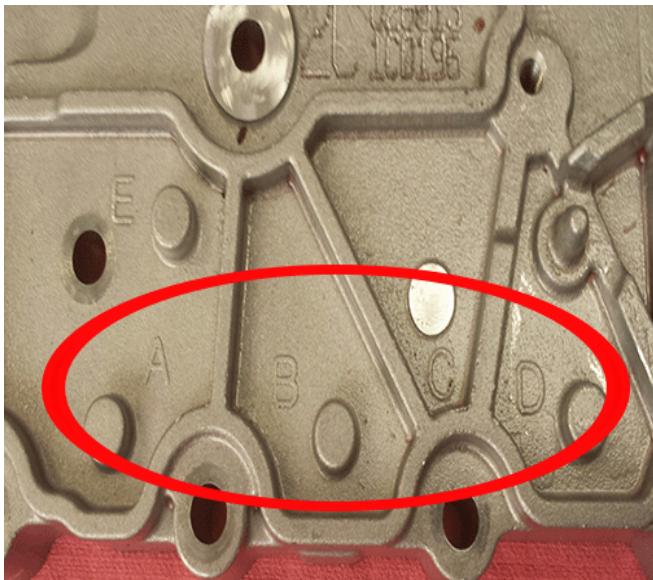
4498516

The post corresponding to the correct RPO will be milled off. In this case the "C" post is milled indicating that this is an MYC upper valve body. A milled "A" post indicates MYA, a milled "B" indicates MYB, a milled "C" indicates MYC and a milled "D" indicates MYD.

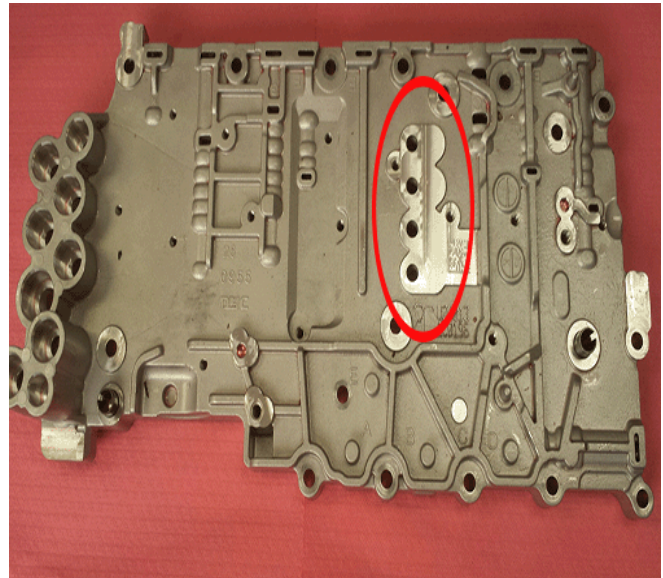
4498521

The oil passage holes that feed the center support and Low and Reverse Clutch and 2-6 Clutch contained within the center support vary location by transmission and corresponding upper valve body. The ISS and OSS mounting locations also vary by transmission. The incorrect valve body does not properly locate the oil feed holes and speed sensors.
