Service Bulletin

Bulletin No.: 16-NA-137

Subject: Mobile Telephone Microphone Poor Performance

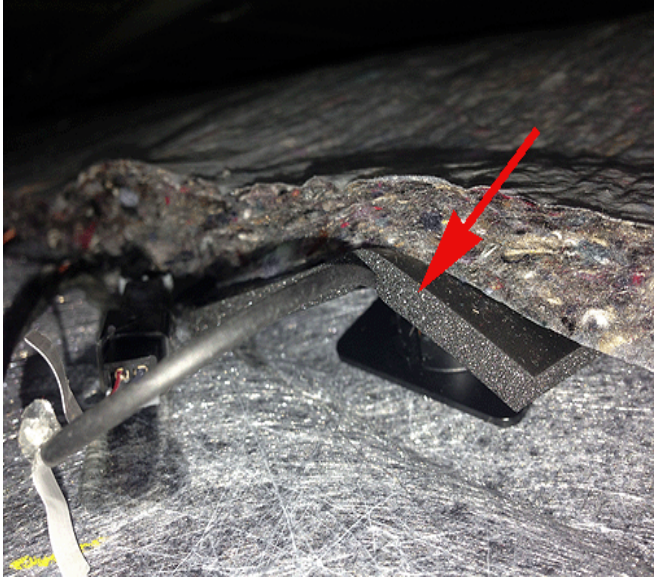
<p style="text-align: right;">3541395</p> <p>This may be caused by the foam patch on the back of the headliner at the microphone mounting area coming loose. This foam is a sound barrier for the back side of the microphone. If the patch is detached, it allows unwanted noise to interfere with the microphone operation when making a phone call.</p>
---------------------	---

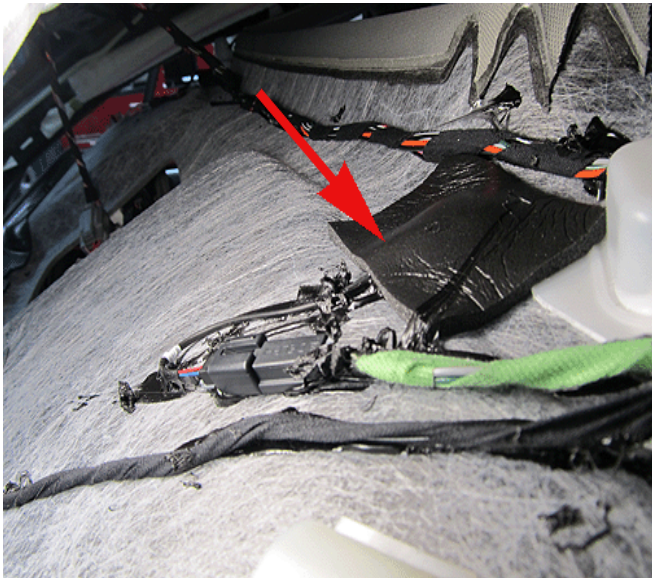
Note: This photo shows a 2014 Traverse – other models will be similar but not identical to this photo.

2. Locate the mobile telephone microphone. Remove the existing foam patch on the back of the microphone. Use care to not dislodge the microphone assembly or wiring.

Note: If the foam is equipped with a cut out for the cable, ensure that the cable is positioned properly and exits through this cut out rather than the edge of the patch.

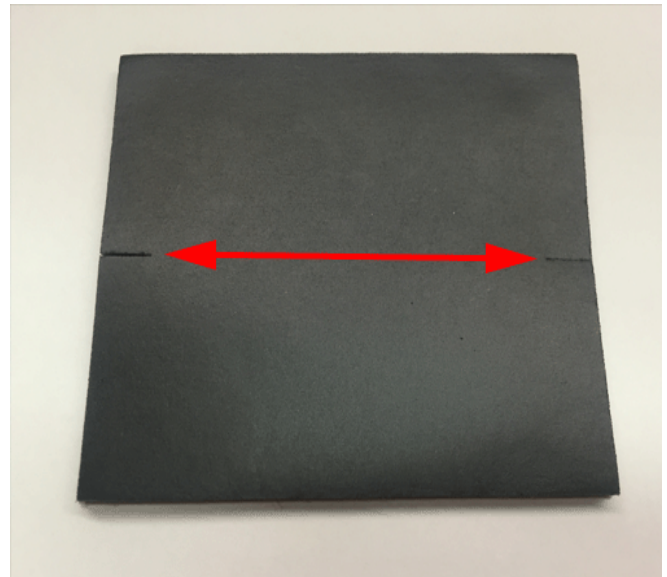
- This photo shows the replacement microphone patch, which is designed to improve microphone performance through the use of dedicated cut outs that are designed to fit around the harness as well as an updated felt material that is glued over the foam.

3. Install a new foam patch:

Note: Use care to center the patch over the microphone before sticking the patch down.

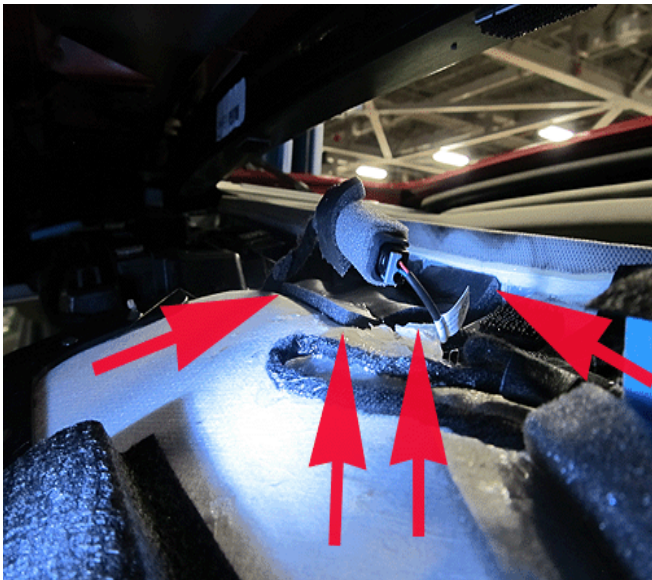
3687736

Note: This photo shows a 2014 Traverse – other models will be similar but not identical to this photo.

- Firmly adhere the patch to the microphone and surrounding area, ensuring there are no gaps between the foam and headliner.
4. Inspect the mobile telephone microphone wiring harness and verify the harness is firmly attached to the headliner trim panel.

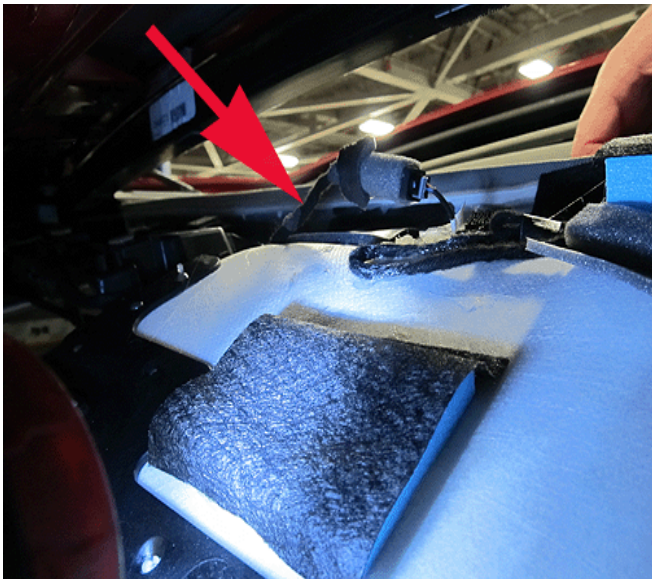
3687740

Note: This photo shows a 2014 Traverse – other models will be similar but not identical to this photo.

If the wiring harness is not firmly attached, using a hot glue gun, apply GM P/N 12377914 (in Canada, use 88864881) Hot Melt Adhesive to firmly attach the harness to the headliner trim panel.
