**SERVICE BULLETIN**

**NUMBER:** 03-70-12R  
**DATE:** 12/13/12  
**REVISED:** 01/03/13

**SUBJECT:** Repair Procedure for High-Pitched Sound from Extension Housing Area Using Latest Generation Production Parts

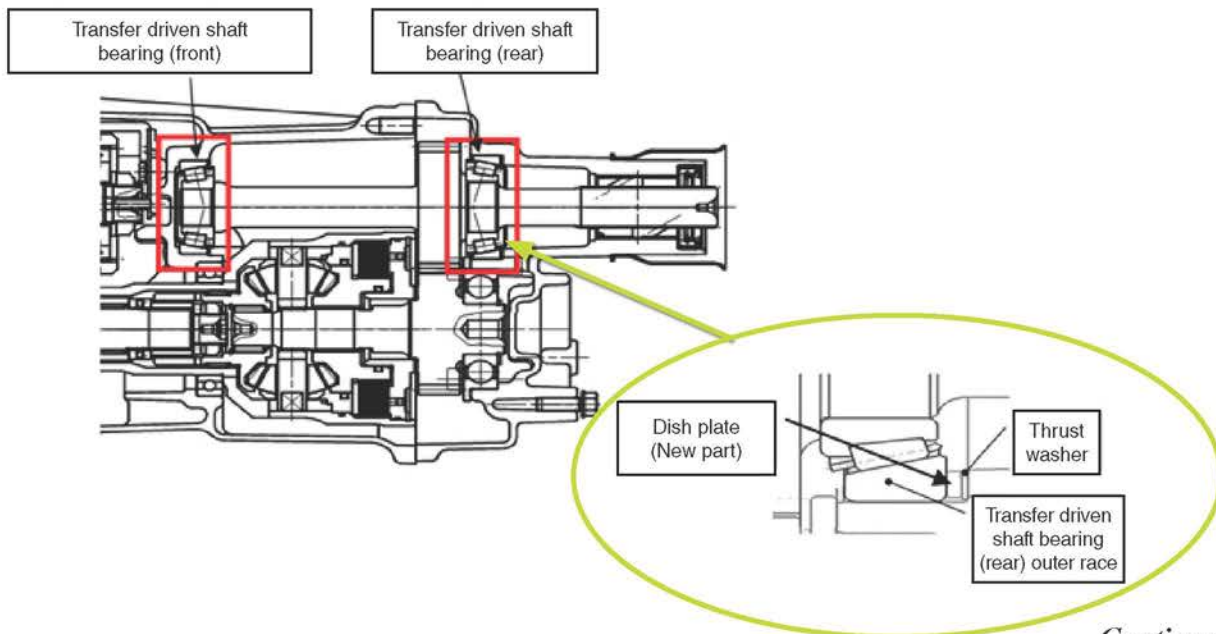
In cold temperatures, thermal contraction causes shrinking of the transmission case. In high temperatures, expansion of the case occurs. These temperature changes affect the amount of pre-load on the transfer driven shaft bearings. In some rare cases, when preload is very near the limit of specification combined with unusual driving conditions, this thermally-induced pre-load change may cause damage to the bearings and result in the sound heard by the customer.

A change has been made to the extension case and a new “Dish Plate” added. The machining depth of the extension case has been increased to accommodate the new dish plate. When used along with a selective thrust washer, the spring tension of the dish plate helps to maintain a consistent amount of pre-load on these bearings throughout varying temperature conditions.
