**NUMBER:** 18-068-16

MIL Illumination: DTCs P112C and/or P112D

This bulletin involves replacing the Post Catalyst Position O2 Sensor.

Jeep Cherokee

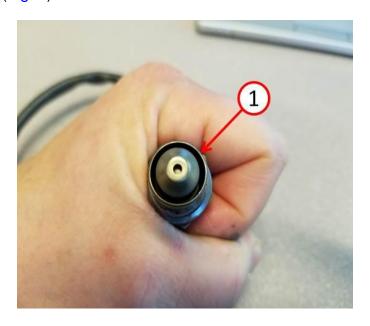
Fig. 1 Old O2 Sensor

1 - Old sensor (without holes)

- 4. Is the oxygen sensor that was removed the old design?
  - a. YES>>> Install the new updated design oxygen sensor.
  - b. NO>>> This Bulletin does not apply. Normal diagnosis should be performed.
- 5. Clear any DTCs that may have been set in any modules.
- 6. Lower the vehicle. Refer to the detailed service procedures available in DealerCONNECT> TechCONNECT under: Service Info> 04 Vehicle Quick Reference> Hoisting> Standard Procedure.

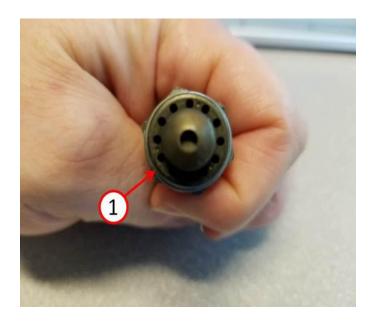
Fig. 2 New O2 Sensor

1 - New sensor (with holes)
