TECHNICAL BULLETIN
JTB00368NAS3
28 JUN 2016

SECTION: 501-17

Panoramic Roof 'Creak' Noise While Driving with Roof Opening Panel Closed

XJ Range (X351)

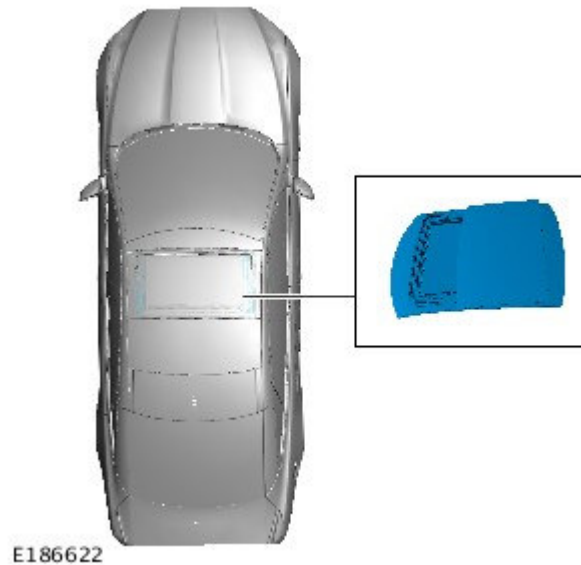
1. Component location.

Situation: The Panoramic Roof may exhibit a 'creak' noise while driving with the roof opening panel in the closed position. Creaking noises from the rear edge of the roof opening panel area, only when the opening panel in the closed position, during vehicle torsional inputs. This bulletin is a potential addition to the Service Instruction originally included in Service Action K117 (now expired) as this particular concern will normally occur while driving with the roof opening panel closed over undulations in the road such as, but not exclusively: drain covers, traffic calming measures, and uneven road surfaces.

- The roof opening panel rear edge interior tooth feature coming into contact with the roof frame when closed; **and/or**
- Movement between the sliding roof panel mechanism arm and the locking arm during torsional inputs to the vehicle.
