FORD:

2016 E-350, E-450

Some 2016 E-Series cutaway vehicles built on 10/1/2015 and through 2/26/2016 may exhibit a cargo box courtesy lamp which remains illuminated with the switch in the off position due to a wiring harness concern.

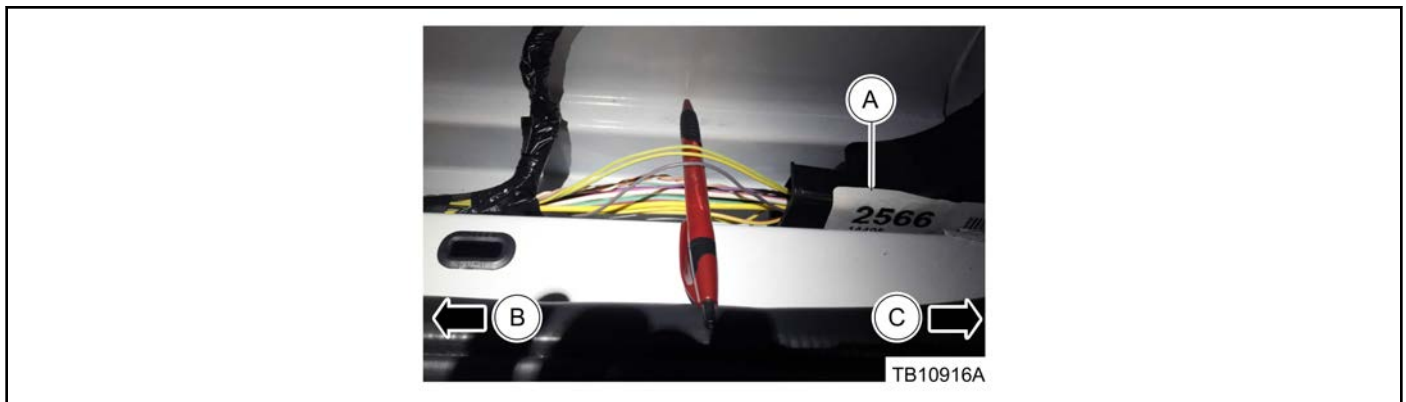
Figure 1 - Article 16-0091

1. Remove the driver front door scuff plate. Lift up to remove the driver front door scuff plate.
2. Locate harness part number tag. Does the harness part number tag read DC2S-14405-DE? (Figure 1A)

- a. Yes - proceed to Step 3.
 - b. No - this article does not apply. Refer to Workshop Manual (WSM), Section 417-02 for normal diagnostics.
3. Disconnect the negative battery cable. Refer to WSM, Section 414-01.
 4. Expose the wires and locate the two YE-GN wires. (Figure 1)
 5. Cut one of the two YE-GN wires.
 6. Check for continuity between the wire routed toward the front of the vehicle (Figure 1B) and C432 pin 7 YE-GN located at the rear of vehicle. (Figure 2) Does the wire have continuity?
