Service Bulletin

Bulletin No.: 16-NA-146

Subject: Power Liftgate Does Not Stay Fully Open or Drifts Down a Few Inches

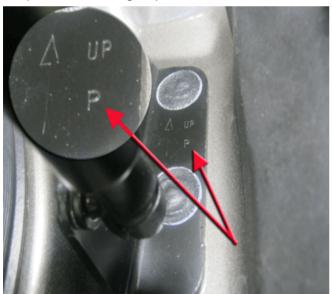
2598278

Open the liftgate and inspect all four of the liftgate mounting brackets for a letter P or M stamped on the bracket.

Note: P is for a power liftgate system and M is for a Manual liftgate system.

If Manual strut mount bracket(s) are found on the vehicle, replace with the correct bracket(s) for power liftgate.

Note: Be sure to tighten the brackets to 25 N·m +/- 5 N·m
