Field campaign

Topic	Bentayga - Air Suspension (SC16/22)
Market area	Russische Föderation (5RU),Australia E04 Bentley rest Asia and Australia (6E04),China 796 VW Import Comp. Ltd (Vico), Beijing (6796),Germany E02 Bentley rest Europe (6E02),Hong Kong 966 Volkswagen Group Hongkong/Macau (NSC) (6966),Russian Federation 935 Volkswagen Group RUS (6935),United Arab Emirates E06 Bentley Middle East and Africa (6E06),United Kingdom E01 Bentley UK (6E01),United States E05 Bentley USA and rest America (6E05)
Brand	Bentley
Transaction No.	2044925/2
Campaign number	EA60
Note	
Type	Workshop Campaign
US code

Bentayga

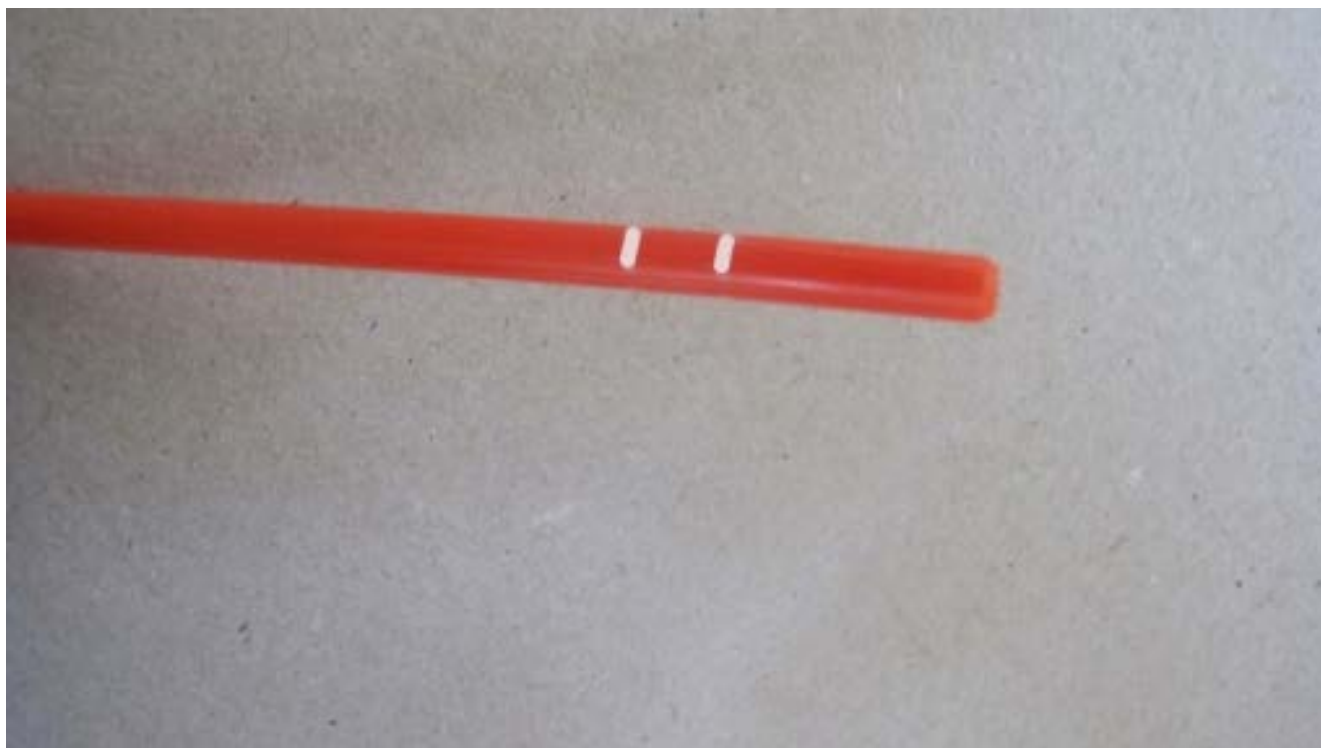
Figure 1

Suspension air pipes connected to the Air Supply Unit may have been fitted incorrectly during manufacture. This condition could lead to loss of air from the Suspension and a warning message to be displayed on the Driver Instrument Panel.

Air pipes to be checked and if required correctly repositioned. White timing marks are used to identify the correct fitting location – figure 1.

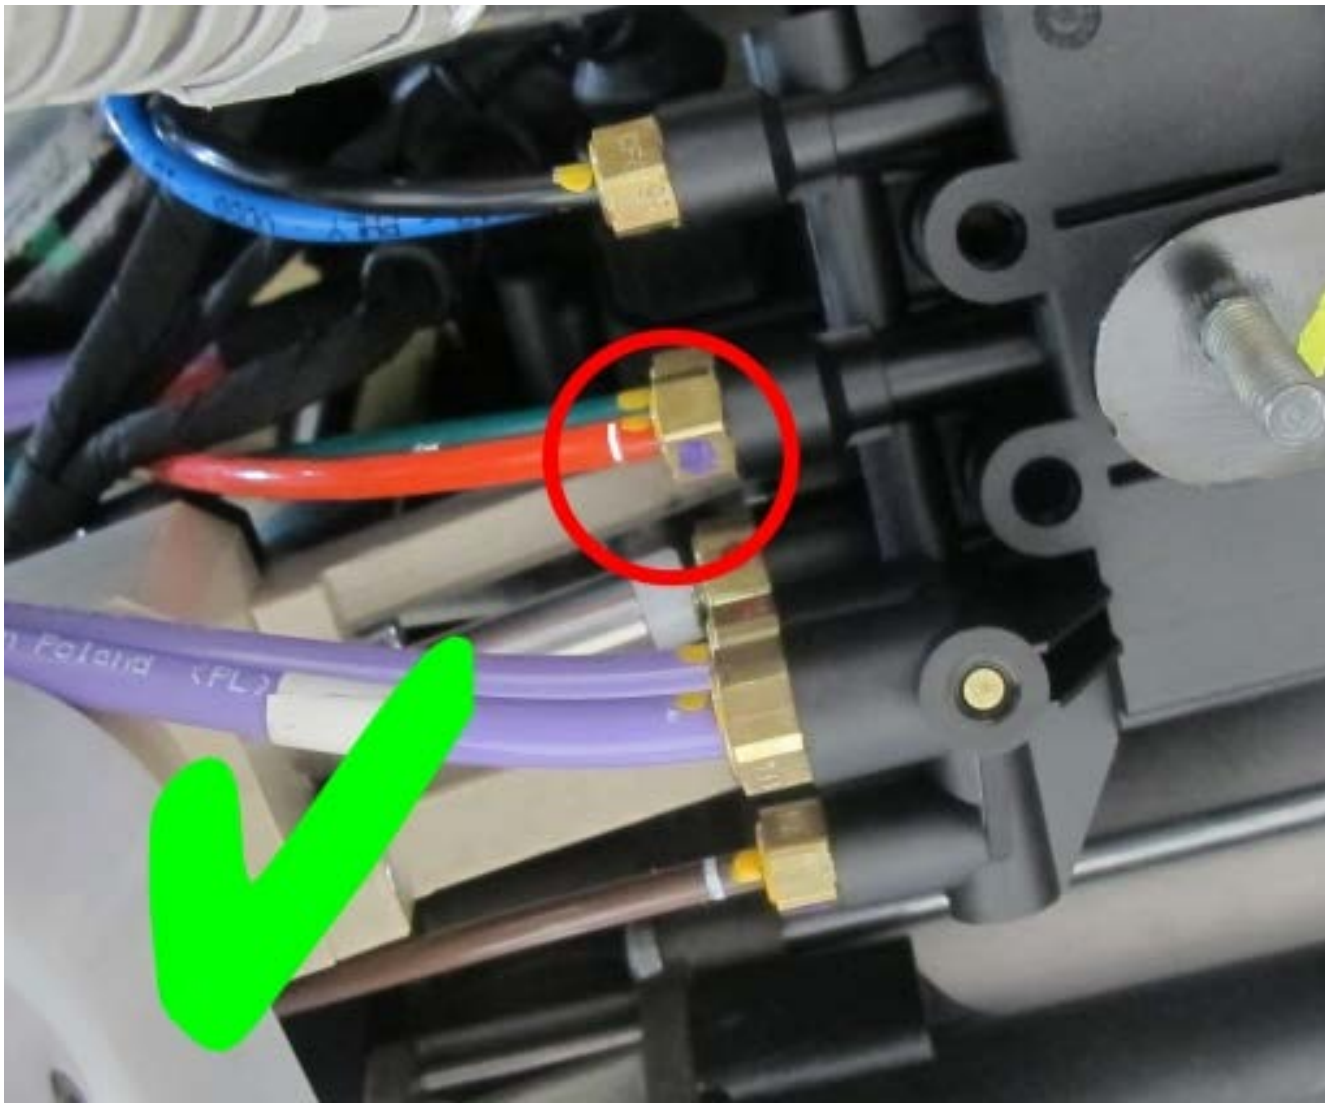
Figure 2

Visually inspect the White timing marks on each pipe connected to the Valve Block. There are two timing marks on each pipe, if correctly positioned it is only possible to see one of the timing marks – figure 2.

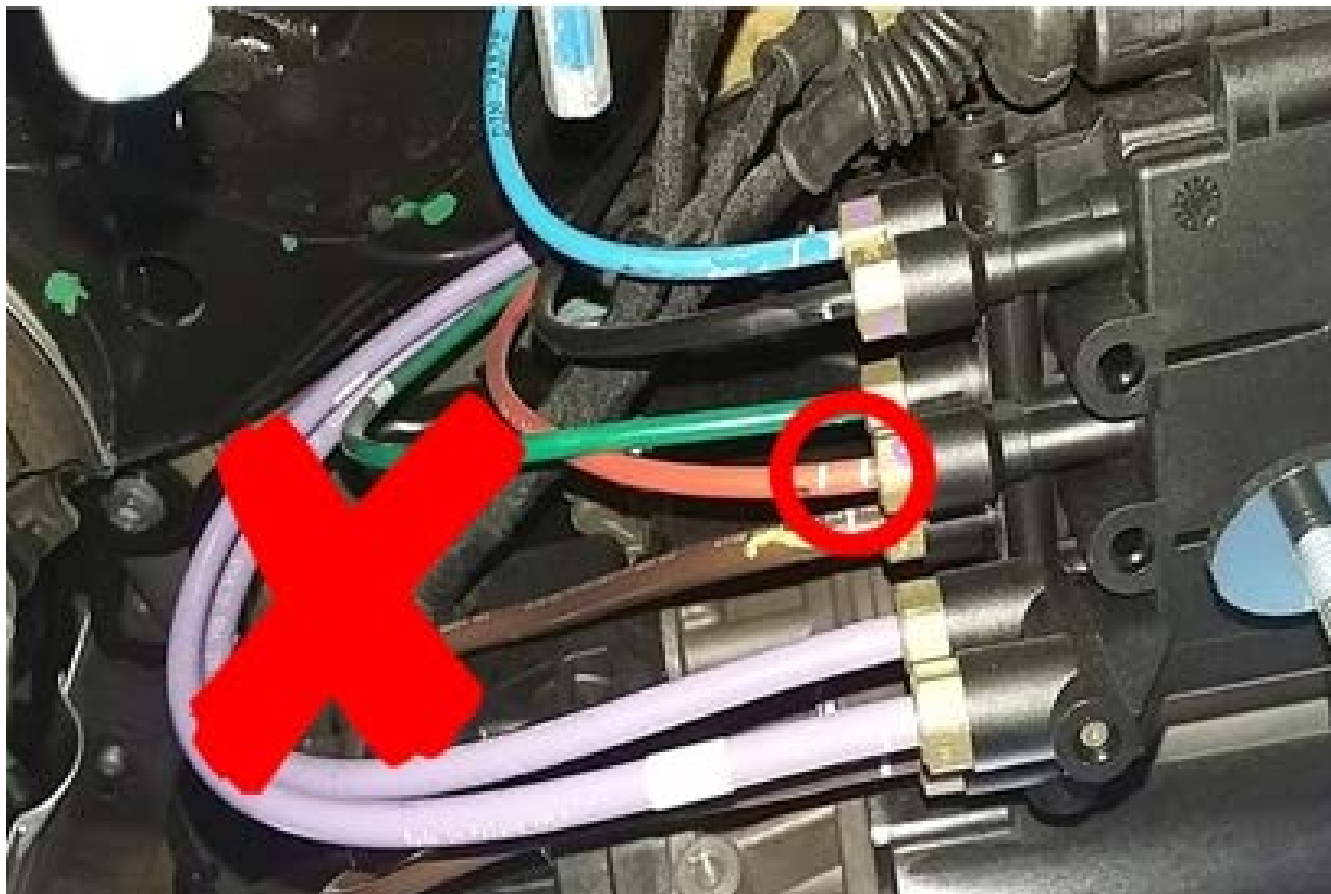
Figure 3

Where two timing marks are visible – figure 3 – pipes should be repositioned into the valve block as shown in figure 2 – refer to Repair Group.43, Self-Levelling Air Spring System, Air Suspension, Solenoid Valve Block – To remove and fit.

If a pipe needs to be repositioned, inspect the internal olive for damage and replace as necessary

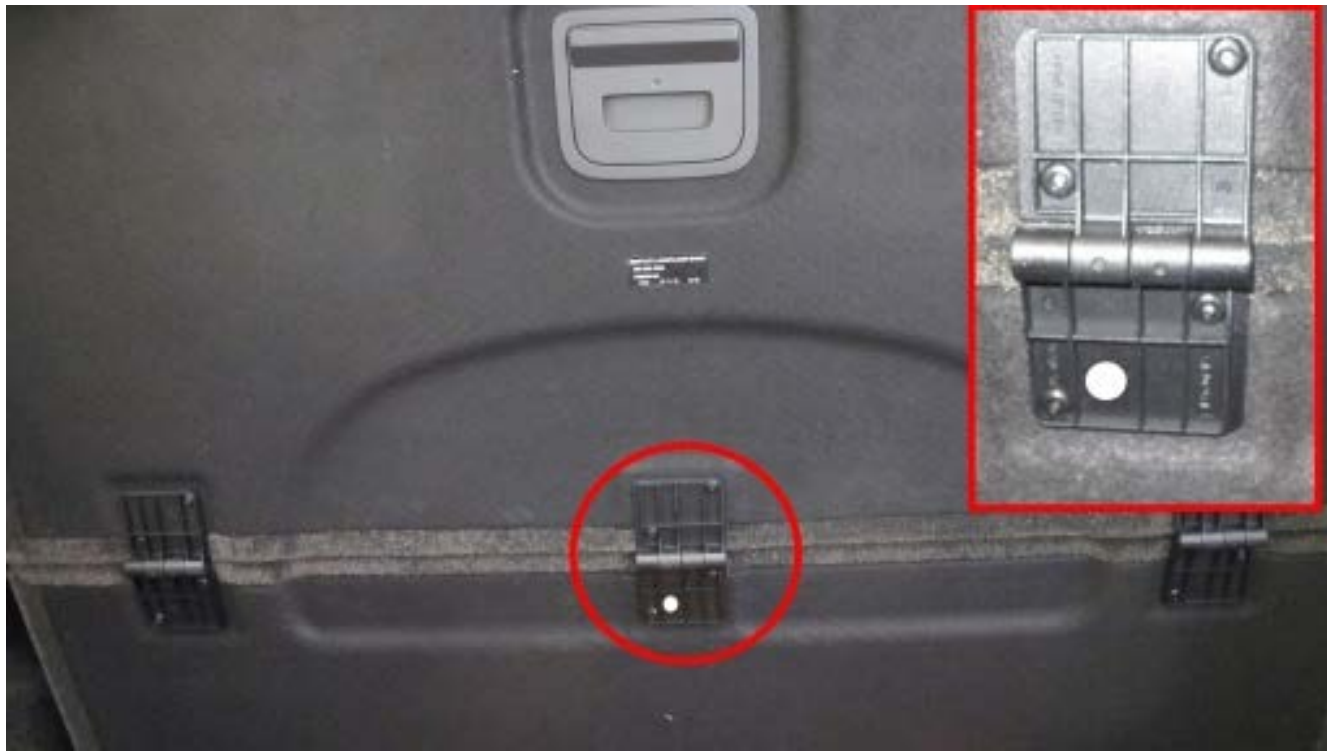
Figure 5

White completion mark on the centre hinge, underside of the luggage compartment floor – figure 5.
