Technical Service Bulletin

20 Problems fueling vehicle and/or MIL on (DTC P044100 or P045100)

20 16 72 2044667/1 June 27, 2016.

| Model(s) | Year | VIN Range | Vehicle-Specific Equipment |
|---|---|---|---|
| RS 5, RS 5 Cabriolet | 2013 - 2015 | All | Not Applicable |

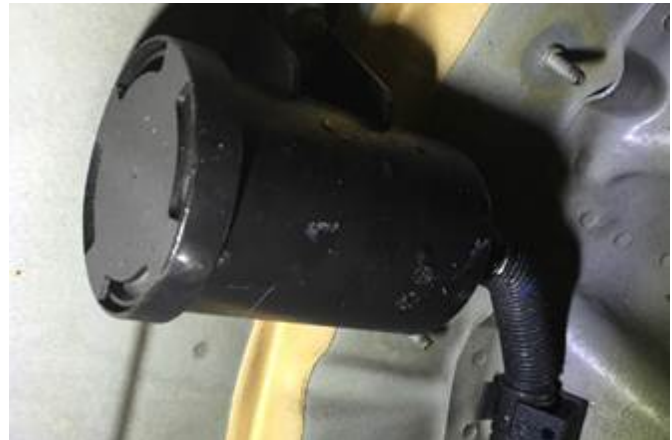
Water enters through the tank ventilation system. The water can flow through the NVLD pressure switch into the activated charcoal filter and freeze in cold temperatures.

Figure 1. Ventilation tube of the activated charcoal filter.

1. Remove activated charcoal filter, ventilation tube, and NVLD pressure switch. Cap off opening to prevent any liquid from escaping.
2. Weigh activated charcoal filter:
 - If it weighs more than 2600 grams, replace the activated charcoal filter, ventilation tube (Figure 1), and NVLD pressure switch.
 - If it weighs less than 2600 grams, replace the ventilation tube (Figure 1) and the NVLD pressure switch.
