TSB150057

Aftertreatment Outlet NOx Sensor Water Intrusion Resulting in Fault Code 1887, 3583, or 3545

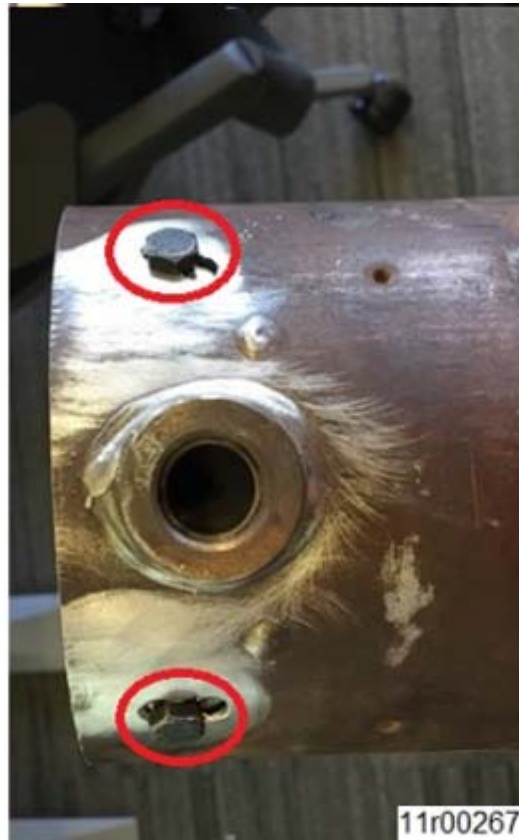
- Inspect for two bolts installed in the tailpipe near the outlet NOx sensor. See Figure 1 below.
- Verify the build of the engine serial number (ESN) is August 2015 or later. This can be done using the physical engine dataplate or QuickServe® Online dataplate.

Figure 1, Two Outlet Nox Sensor Bolt-In Water Shield Bolts in the Exhaust Pipe.

If symptom has been verified, the aftertreatment outlet NOx sensor bolt-in water shield **must** be installed. See Installation Instructions 4908441, for details on how to install the aftertreatment outlet NOx sensor bolt-in water shield.
