HYUNDAI NEW THINKING. NEW POSSIBILITIES.	GROUP CAMPAIGN	NUMBER 16-01-019
	DATE APRIL 2016	MODEL(S) TUCSON (TL)
Technical Service Bulletin		
SUBJECT: BATTERY TERMINAL AND MOUNTING BRACKET INSPECTION (SERVICE CAMPAIGN TCC)

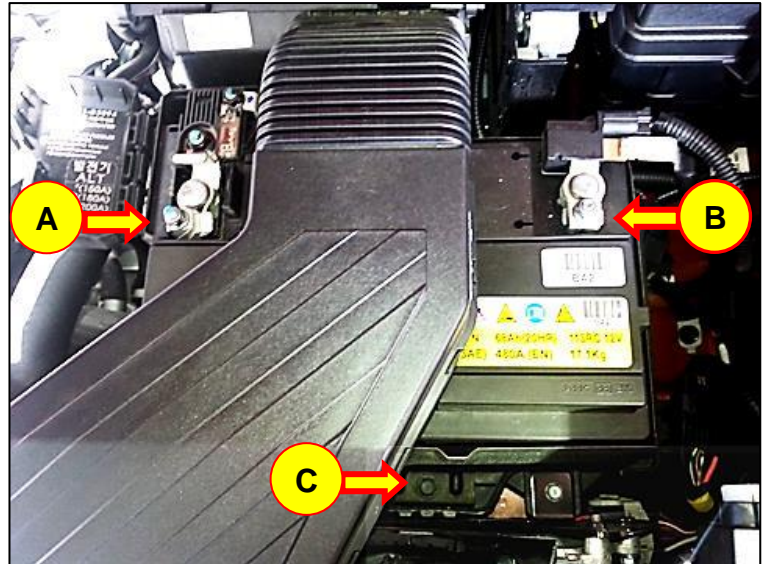
During recent rework at a port facility, the battery terminals and battery mounting bracket bolts might not have been secured properly.

1. Open the hood.
2. Verify both battery terminal clamps (A) and (B) are fully seated and securely fastened. Use a 10 mm socket or wrench to verify the clamp torque on each terminal.

Inspect that the battery is firmly seated in the battery tray.

Inspect mounting bracket is installed properly.

Verify the battery mounting bracket bolt (C) is properly tightened by using an appropriate 10 mm socket.

**Battery (-) terminal: 3.0 ~ 4.4 lb-ft
(4.0 ~ 6.0 Nm)**

**Battery (+) terminal: 5.8 ~ 7.2 lb-ft
(7.8 ~ 9.8 Nm)**

**Tightening torque: 6.5 ~ 10.1 lb-ft
(8.8 ~ 13.7 Nm)**
