TSB160010

INSITE™ Electronic Service Tool Error When Adjusting Aftertreatment Diesel Exhaust Fluid Level System Configuration Programmable Parameters

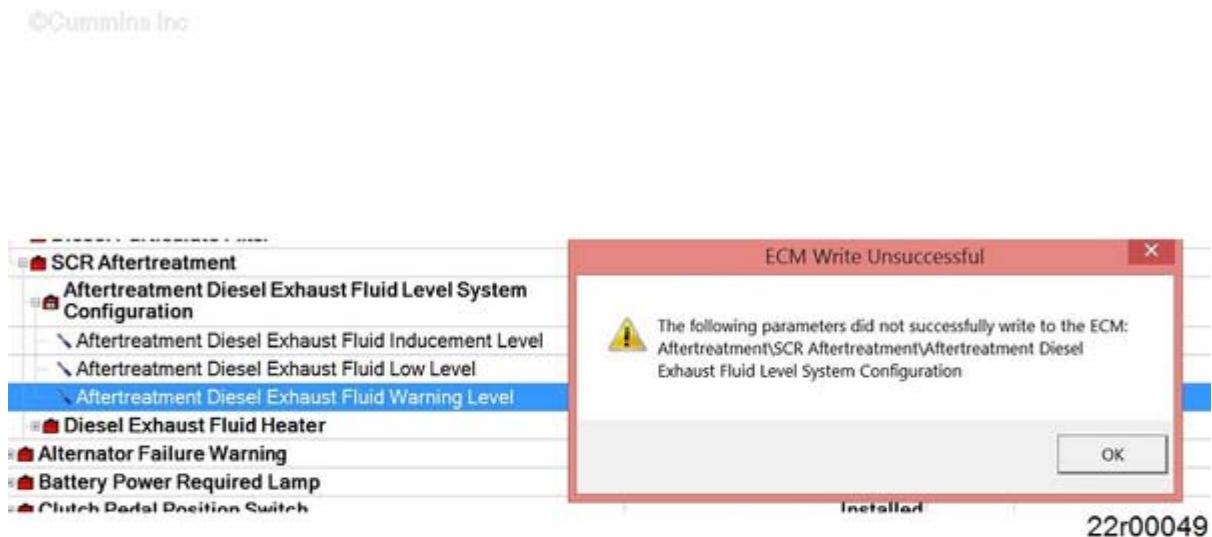
When adjusting the values of Aftertreatment Diesel Exhaust Fluid Inducement Level, Aftertreatment Diesel Exhaust Fluid Low Level, or Aftertreatment Diesel Exhaust Fluid Warning Level with INSITE™ electronic service tool on Model Year 2015 and Model Year 2016 engines, an error message will display as shown in Figure 1 below.

Figure 1, ECM Write Unsuccessful Error Message

- Disregard the engine control module (ECM) Write Unsuccessful error message. The parameters will write and save to ECM memory.
- The error message issue will be resolved in a future software release scheduled for mid-year 2016.
