Service Bulletin

Bulletin No.: 16-NA-241

Subject: Engine Misfire, Ticking/Knocking Noise, No Compression due to Piston Damage, Malfunction Indicator Lamp (MIL) Illuminated

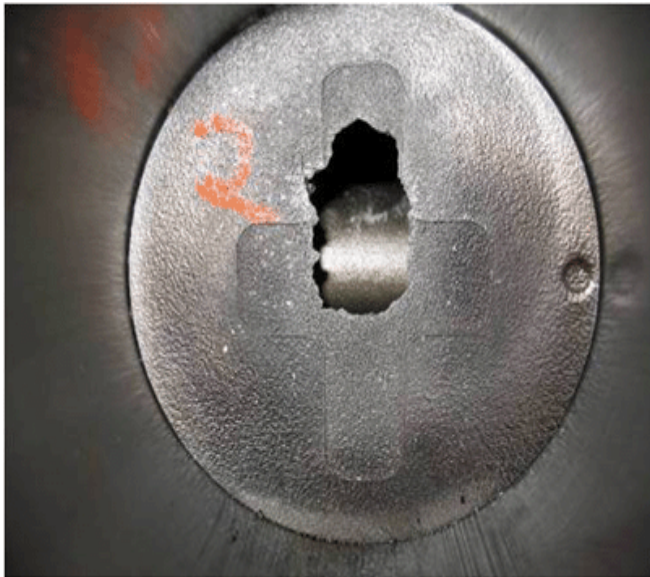
2222086

1. If a lighted bore scope is available, inspect the top of the related piston(s) through the spark plug hole to determine if any of the pistons are melted as shown below. These photos all show examples of pistons that were damaged/melted due to detonation that was induced from aftermarket calibrations and/or components. If this type of piston damage is noted, it is most likely the result of aftermarket ECM calibrations and/or components. Follow the remaining steps to
