## Battery Cable Routing CXU

### PI0802, Battery Cable Routing

(December 2012)

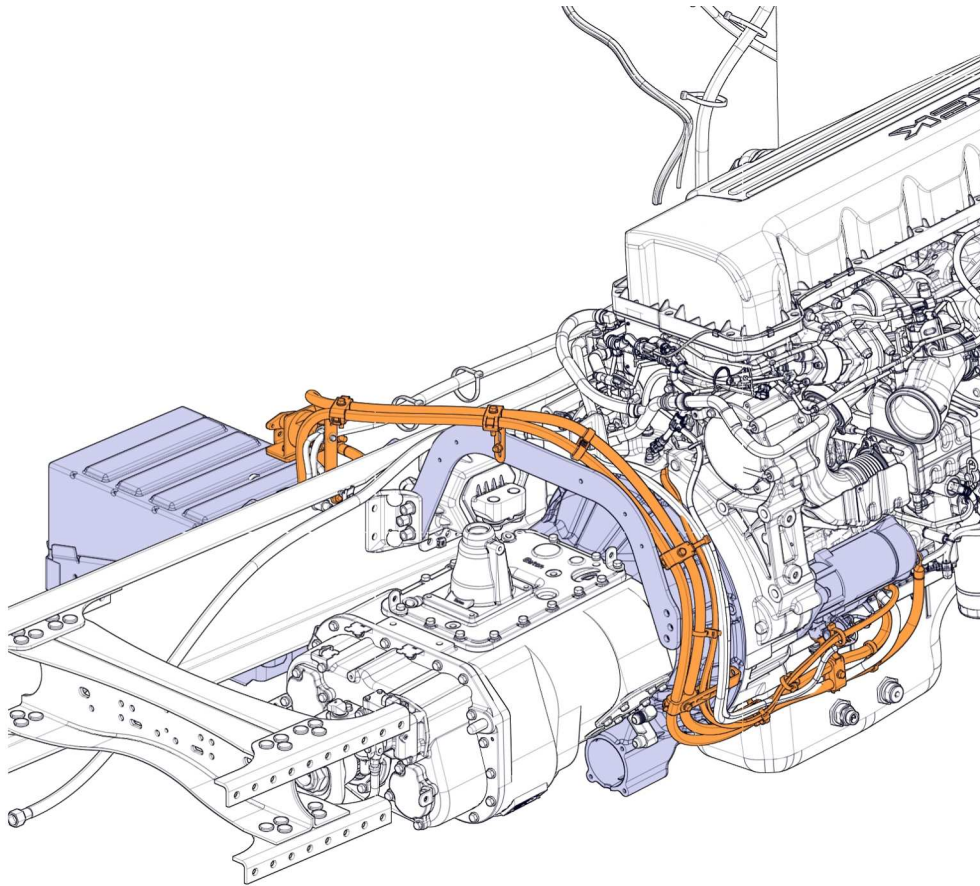
W3077591

On certain Mack Trucks built between August 14, 2009 to October 21, 2011, the battery cables may rub on the over slung cross member. The cable contact point is located between the clutch housing and the clipping point on the frame behind the battery box. This is due to improper routing of the cables.
