Field Service Bulletin Trucks

Date	Group	No.	Release	Page
7.2013	371	045	02	1(4)

Battery Starter Lug Failure
CXU, GU

FSB 371-045, Battery Cable Lug, Failure

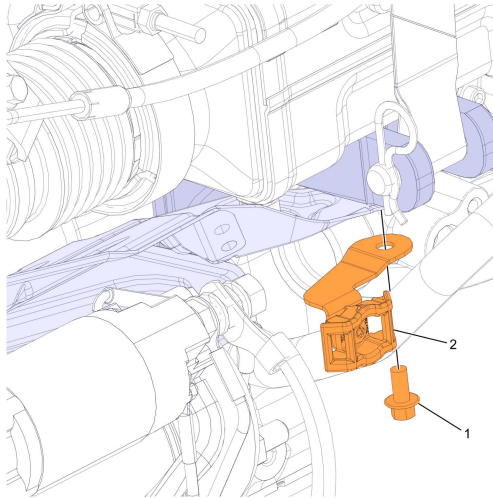
W2080362

1. Socket Screw
2. Saddle

- 5 Install the bracket onto the vehicle and secure.

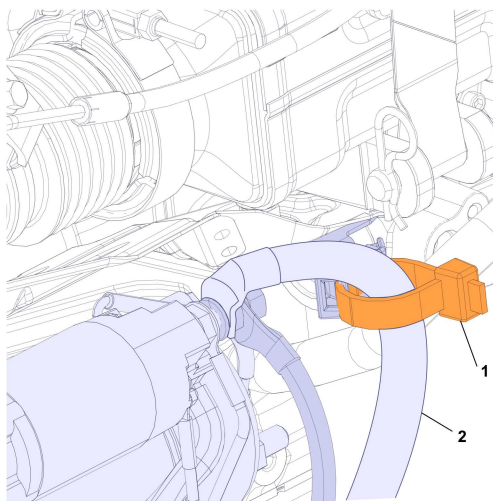
W2080364

Certain vehicles built from January 1, 2010 to June 14, 2013 with a MP7 engine may experience cracking or breaking of the 90 degree positive battery cable lug at the starter solenoid stud. In some cases, the lug is bent during assembly, and along with engine vibration may cause the terminal to weaken and fail over time.

1. Cable Tie
2. Positive Battery Cable

- 6 Install the cable tie around the saddle and the positive battery cable going to the starter solenoid.

Note: Battery cable may need to be loosened/retightened from back of starter solenoid in order to reach the saddle. Tighten to 26 ± 1.5 Nm (19.2 ± 1.1 ft lb).
