## Power Divider Lockout Leakage, Repair CHU, GU, LEU, LR, MRU, CXU, TD

### FSB 468-001, Power Divider Lockout Leakage, Repair

(March 2016)

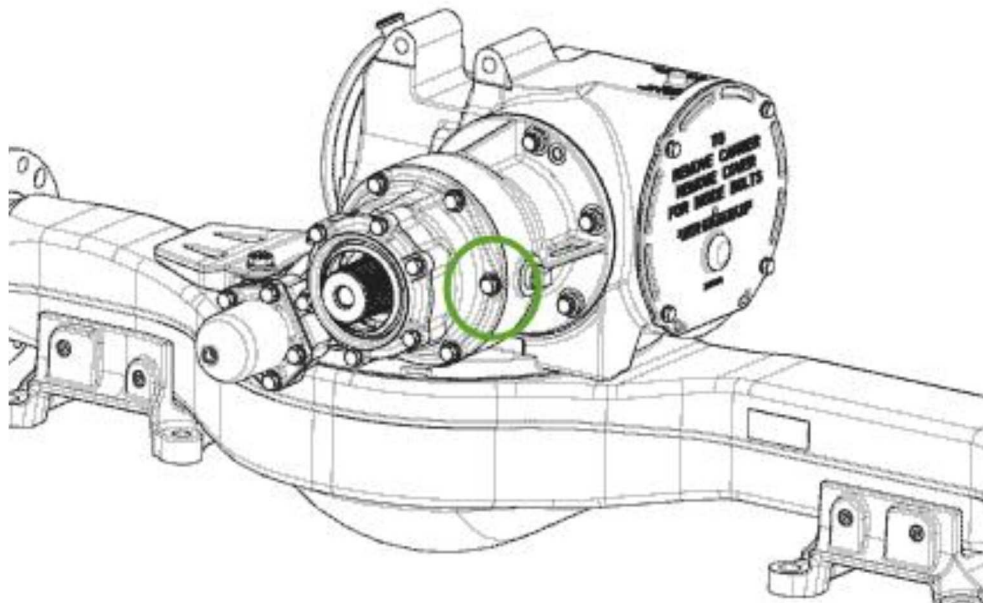
W4111064

On MACK vehicles built between July 6, 2015 and January 15, 2016 equipped with a MACK CRD 150 carrier, the mounting bolt hole on the driver side of the power divider housing which lines up with the fill plug is drilled through to the fill plug hole. This can create a path for a leak around the threads of the mounting bolt. The remaining five mounting bolt holes are blind. When a leak is found in this area, verify that all six mount bolts around the flange are tight. If any of the mounting bolts are found to be loose, the power divider lockout (PDLO) assembly must be removed and the gasket replaced. If all the bolts are tight, the bolt at the 3:00 position should be removed and cleaned along with the mounting hole with a residue free cleaning spray like contact cleaner.

- 1 Secure the vehicle for service by parking it on a flat level surface, applying the parking brake, chocking the rear wheels, and placing the transmission in neutral.
- 2 Inspect the PDLO gasket for leakage and check for loose bolts.
  - If no leakage exists and there are no loose bolts, **perform Step 3 only**.
  - If leakage exists or there are loose bolts, proceed to Step 4.
- 3 Remove pass-through mounting bolt, clean the threads and mounting hole. Apply Loctite 567® sealant to bolt threads. Install bolt and tighten to 47 ±5 Nm (35 ±4 lb-ft). If part number 25499834 is used, tighten to 61 ±7 Nm (45 ±5 lb-ft). Check fluid level and add as necessary.

**Note:** Do not apply Loctite 567® to part number 25499834.
- 4 Disconnect drive shaft from PDLO assembly.
- 5 Disconnect airline at shift cylinder.
- 6 Remove PDLO assembly and cam.
- 7 Clean surface of assembly, mounting screw and holes.
- 8 Install cam in PDLO assembly.
- 9 Install alignment dowels in PDLO assembly.
- 10 Install new gasket (part number 25102059) on PDLO assembly.
- 11 Position PDLO assembly.
- 12 Remove alignment dowels.
- 13 Apply Loctite 567® sealant to bolt threads. Install bolt and tighten to 47 ±5 Nm (35 ±4 lb-ft). If part number 25499834 is used, tighten to 61 ±7 Nm (45 ±5 lb-ft).
