# Field Service Bulletin Trucks

Diagnostic Trouble Codes (DTCs), Low Oil Pressure  
CXU, GU, LEU, MRU  
MP7 EPA2010, OBD2013

## FSB 221-010, Diagnostic Trouble Codes (DTCs), Low Oil Pressure

(September 2013)

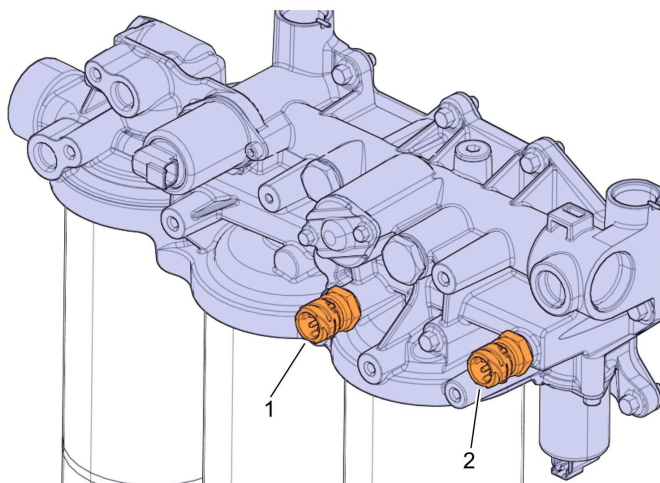
W2084377

1	Engine Piston Cooling Oil Pressure Sensor
2	Engine Oil Pressure (EOP) Sensor

- 1 Secure the vehicle for service by parking it on a flat level surface, applying the parking brake, chocking the rear wheels, and placing the transmission in neutral or park.
- 2 Disconnect all battery cables from the negative (ground) battery terminals to prevent personal injury from electrical shock and prevent damage to electrical components.
- 3 Inspect the oil pressure sensors and note the part numbers on them. If the part number is 21302639 or less, remove and replace the engine oil pressure sensor and engine piston cooling oil pressure sensor with new sensor part number 21634021. Tighten sensors to  $30 \pm 5 \text{ Nm}$  ( $22 \pm 4 \text{ ft-lbs}$ ).
