04078 Version 1

O2 Sensor Bracket Rattle

Year	Model	Trim	VIN Range
2016	HR-V	2WD only	ALL

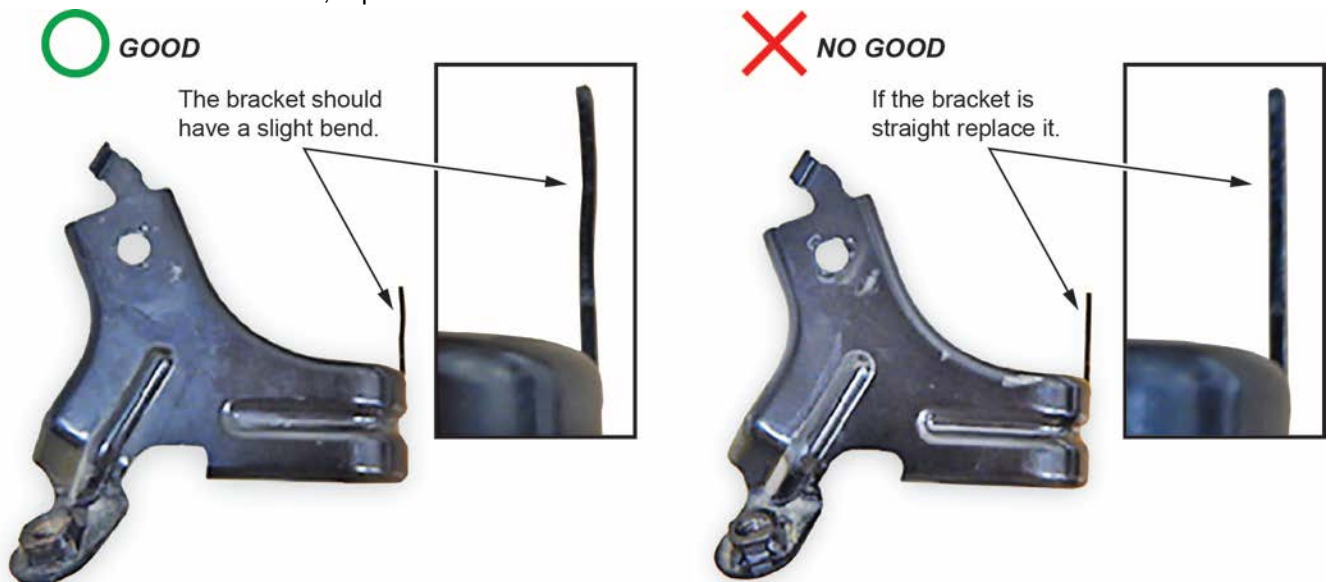
The O2 sensor bracket may not have the correct bend, allowing the harness to rattle.

2. Inspect the bracket.

- If the bracket has a slight bend as shown, the bracket is good. Continue with normal troubleshooting.
- If the bracket has no bend, replace the bracket.

3. Install the new bracket and torque the nut to **9.4 N·m (6.9 lb-ft)**, Then install the harness to the bracket.
