<b>Technical Service Bulletin Number</b>
--

TSB150006
-----------

Leaking Diesel Exhaust Fluid (DEF) from the Aftertreatment DEF Dosing Unit Electrical Connector

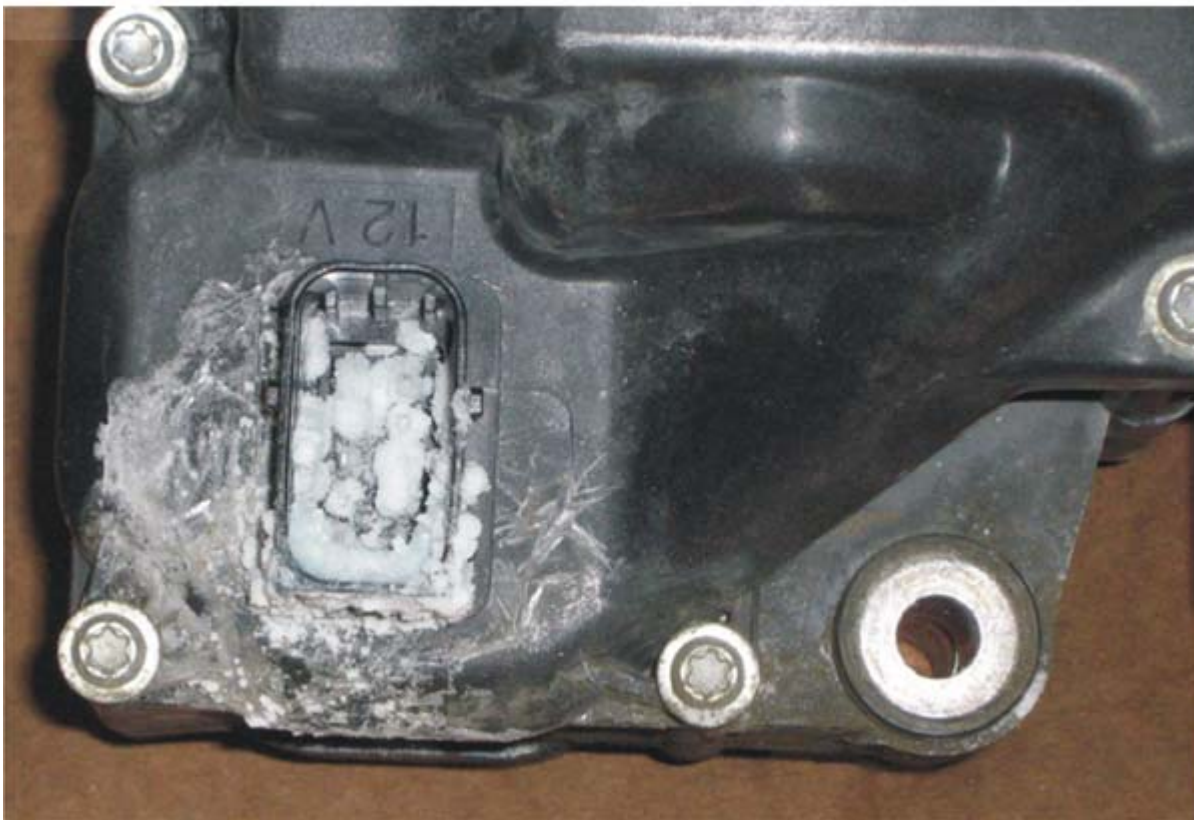
- Diesel exhaust fluid (DEF) can freeze, causing the aftertreatment DEF dosing unit electrical connector to crack and leak DEF.

- Use the appropriate fault code troubleshooting tree to confirm and troubleshoot the corresponding fault codes. See the corresponding Fault Code Troubleshooting Manual.
- During the troubleshooting process, look for evidence of leaking DEF around the aftertreatment DEF dosing unit electrical connector. See Figure 1 below.

If DEF is found leaking around the aftertreatment DEF dosing unit electrical connector, replace the aftertreatment DEF dosing unit. See the corresponding Service Manual. Reference Procedure 011-058 in Section 11.
