# Service Bulletin

**Subject:** Malfunction Indicator Lamp (MIL) On, Poor Acceleration, Throttle Body Freezing, Multiple DTCs Set, Ice Deposits and/or Oil Deposits Present in Air Inlet Duct

**Models:** 2008-2011 Buick Enclave  
2007-2011 Chevrolet Malibu  
2009-2011 Chevrolet Traverse  
2007-2011 GMC Acadia  
2007-2010 Pontiac G6  
2007-2010 Saturn OUTLOOK  
Equipped with 3.6L Engine (RPOs LY7, LLT)

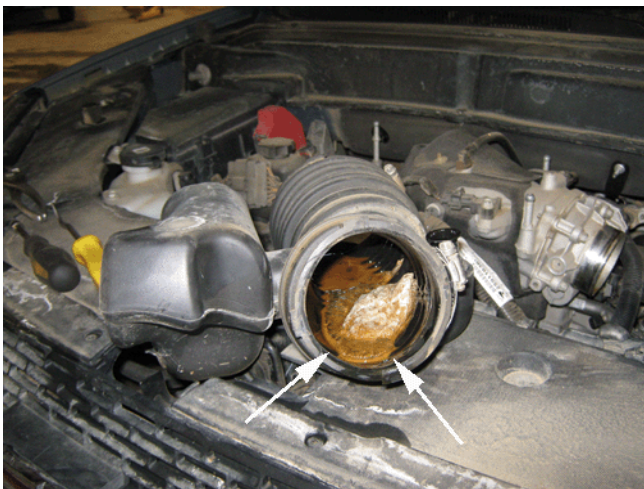
Technicians may find the presence of DTCs P0101, P0171, P0172, P0174, P0175, P1516, P2177, P2178, P2179, P2180, P2187, P2188, P2189, and/or P2190 along with either ice or oil deposits in the air inlet duct.

Ice formation is caused by condensation freezing at the base of the throttle body with additional collection of ice formation deposits in the air inlet duct. Freezing condensation forms after the vehicle has been driven and then parked in low ambient temperatures.

Oil deposits are the collection of the engine vapors, fuel dilution and oil mist at the base of the throttle body with additional formation collecting in the duct.

1. Remove both camshaft covers for servicing of the PCV system. Refer to Camshaft Cover Replacement Left and Right Side in SI.
2. Clean the PCV orifice with low VOC brake cleaner. Allow to air dry with compressed shop air.
3. Replace the bank1 camshaft cover gasket.
4. Reassemble the bank1 camshaft cover.  
**Tighten:** Tighten the camshaft cover bolts to 10♦Y (89♦lb♦in).
5. Replace the bank2 camshaft cover and replace the camshaft cover gasket.
6. Reassemble the bank2 camshaft cover.  
**Tighten:** Tighten the camshaft cover bolts to 10♦Y (89♦lb♦in).
7. Install the insulated PCV tube.
