Technical Service Bulletin Number	Revision Level	Date	Group Number
TSB140048

Leaking Diesel Exhaust Fluid From the Aftertreatment Diesel Exhaust Fluid Dosing Unit Electrical Connector

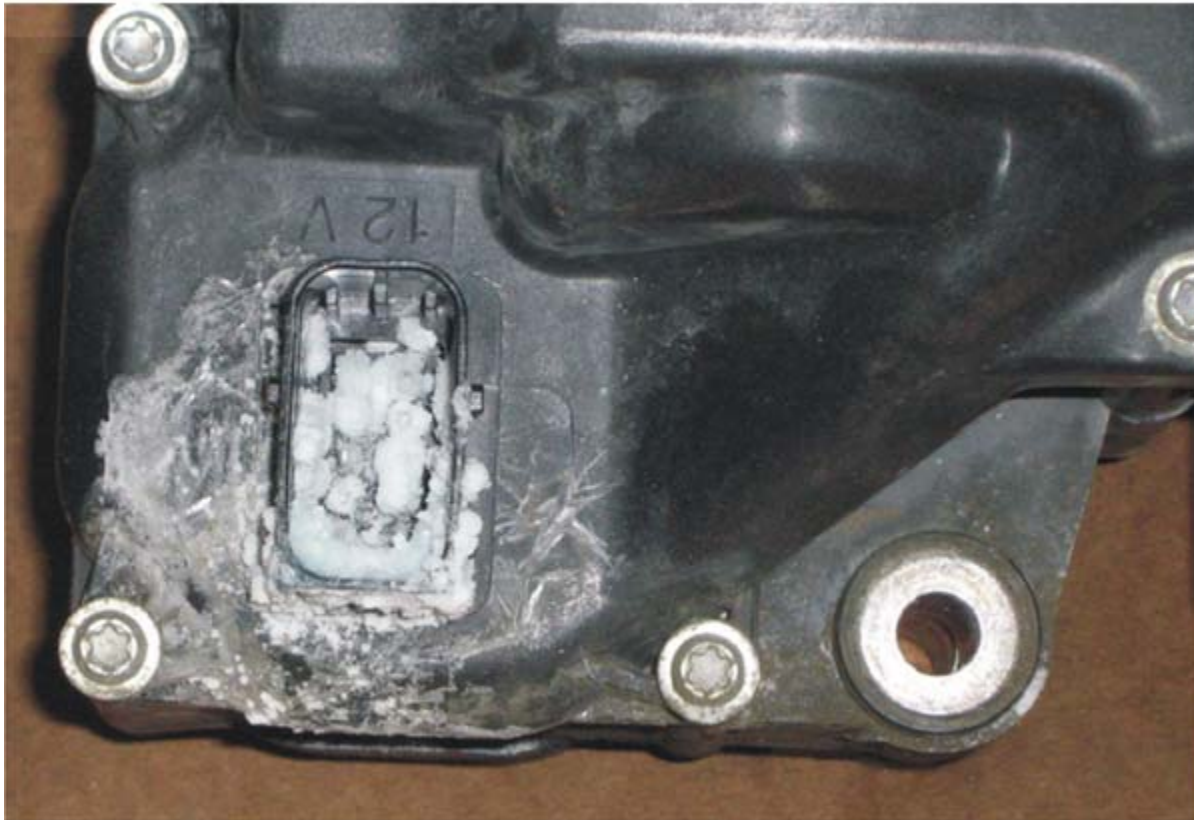
Multiple electrical diagnostic fault codes can be set due to diesel exhaust fluid (DEF) leaking around the aftertreatment diesel exhaust fluid dosing unit electrical connector, caused by internal cracking due to freezing DEF. List of possible fault codes includes, but is **not** limited to; 1682, 1696, 2976, 3558, 3559, 3572, 3574, 3577, 3596, and 4251.

During the troubleshooting process, leaking DEF around the aftertreatment diesel exhaust fluid dosing unit electrical connector is discovered. Figure 1 shows a typical leak.

Replace the aftertreatment diesel exhaust fluid dosing unit. [Refer to Procedure 011-058](#). Update the aftertreatment diesel exhaust fluid controller software phase. Reference Cummins® Aftertreatment Diesel Exhaust Fluid Controller Software Phases, Service Bulletin [4310705](#).
