<b>Technical Service Bulletin Number</b>	<b>Revision Level</b>	<b>Date</b>	<b>Group Number</b>
TSB130182

## Technical Service Bulletin

PACCAR™ Chassis with 2013 CM2350 Heavy Duty and MidRange Engines Setting Fault Codes 1921, 1922, 1981, 3375, and 3376.

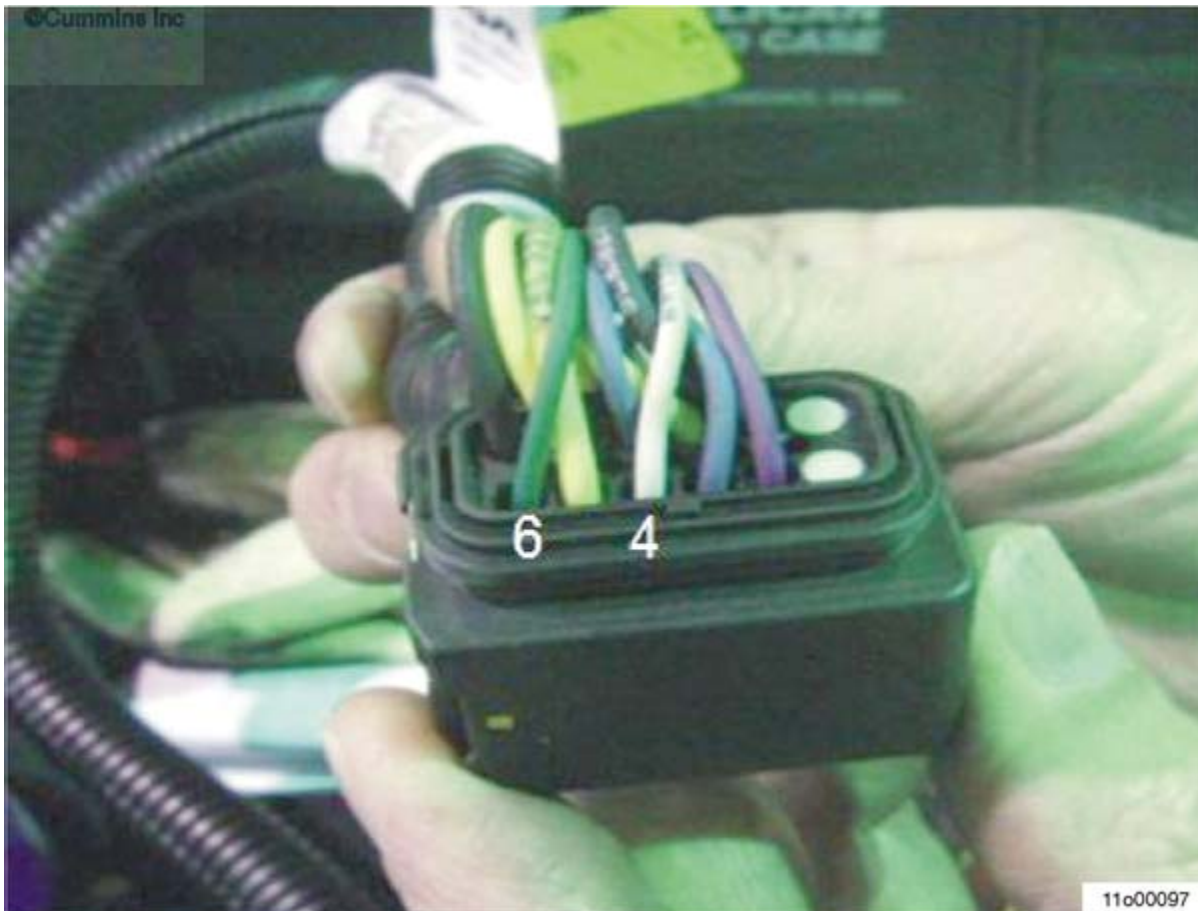
There are two ground wires in the diesel exhaust fluid (DEF) Supply module wiring harness. A green wire (GRN 3231) is the ground wire for the DEF pressure sensor ground return. A white wire (WHI 3232) is the ground wire for the DEF supply module tank heater ground return. The ground wires are installed in the wrong connector cavities on some CM2350 PX7, PX9, ISX12 and ISX15 engines. When the ground wires are installed incorrectly and the DEF supply module heater turns on, Fault Codes 1981,1921,1922, 1981, 3375, and 3376 can occur.

The illustration below depicts the wires in the wrong locations. The green wire (GRN 3231) should be located in the number 4 connector cavity. The white wire (WHI 3232) should be located in the number 6 connector cavity.

Relocate the wires in the connector. The green wire should be inserted in cavity number 4. The white wire should be inserted in cavity number 6.

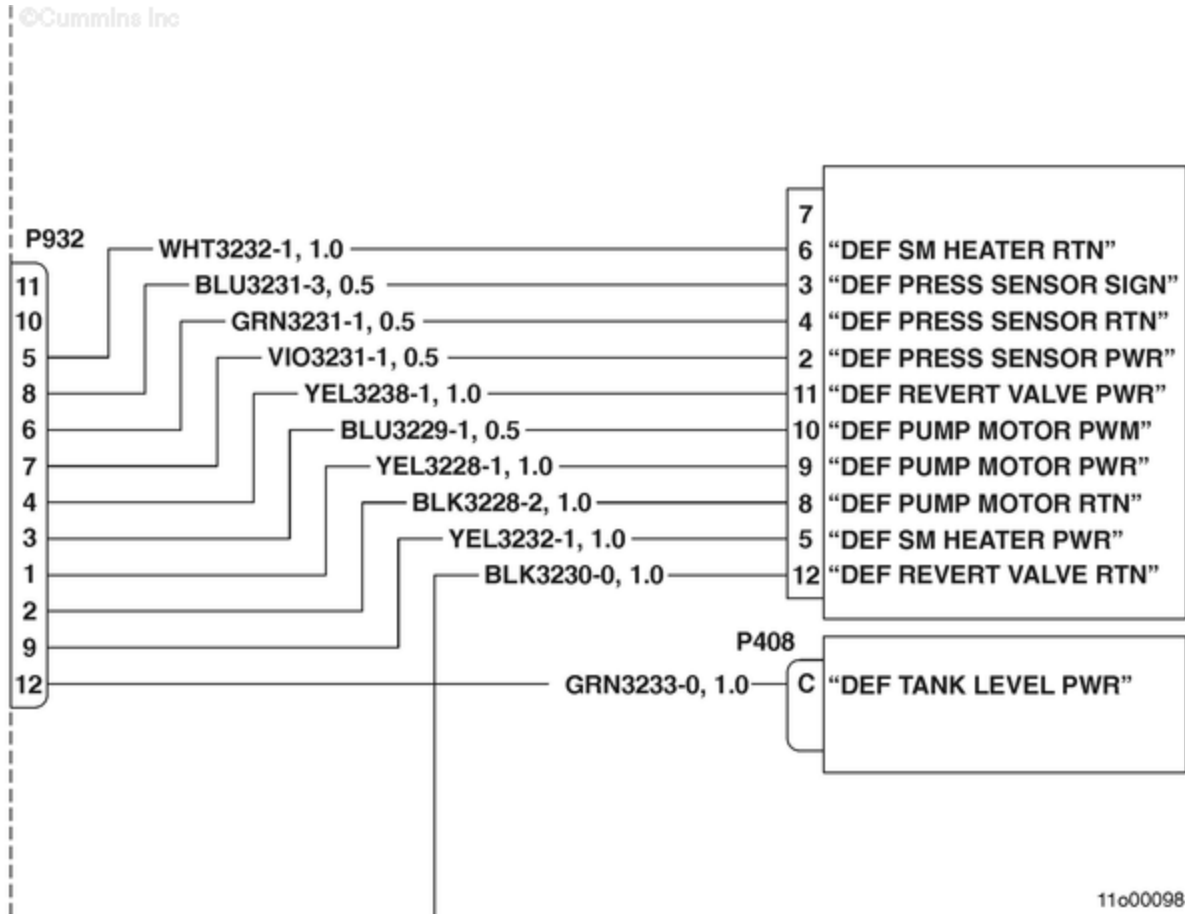
4. Disconnect the DEF tank harness from the DEF supply module. PACCAR™ nomenclature for this harness is the DEF tank harness. Examine connector pins 4 and 6. Pin 4 should be a green wire and Pin 6 should be a white wire. If the pins are incorrect, swap the pins at the DEF supply module connector. Connector P931 (below) shows the **correct** pin outs for pins 4 and 6.
