Technical Service Bulletin Number	Revision Level	Date	Group Number
TSB140019

ISX15 CM2250 and QSX15 CM2250 ECF Fuel Pump - Ceramic Plunger and Tappet Roller Inspection and Repair

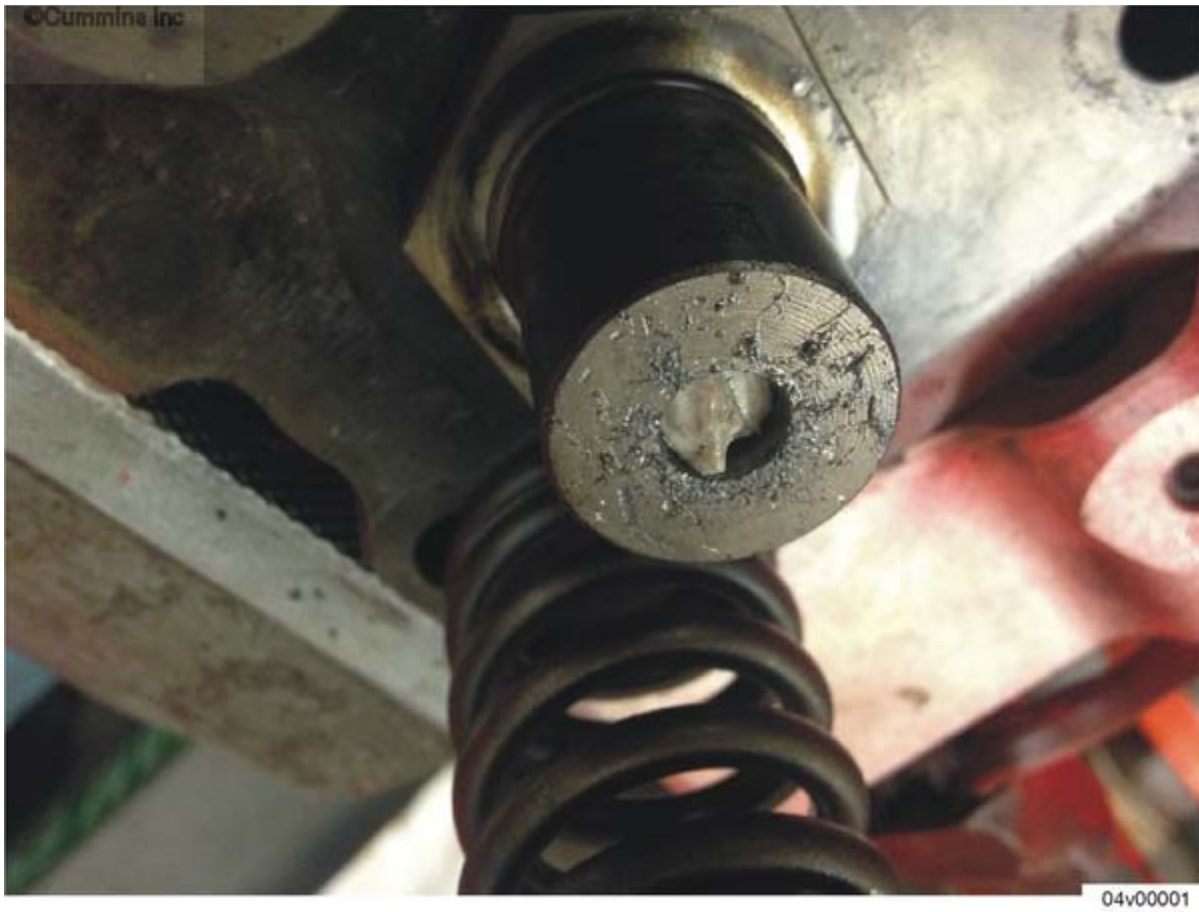
This document, in conjunction with the information provided within the manuals listed in the table above, provides the inspection and repair practice when ceramic plungers are found to be fractured (see Figure 1) and/or tappet roller damage is found on fuel pumps with ceramic plungers (see Figure 2). Ceramic plungers can be identified by their white color. [Refer to Procedure 005-227 in the Associated Procedures Table](#) for removal of the fuel pump head.

Figure 1: Fractured Fuel Pump Ceramic Pumping Plunger

If the ceramic plungers are fractured (see Figure 1), but no damage is found on the fuel pump tappet rollers (see Figure 2), no further inspection is needed. Perform the following steps for the appropriate engine (ISX15 CM2250 or QSX15 CM2250 ECF):

1. Replace the fuel pump. [Refer to Procedure 005-016 in the Associated Procedures Table.](#)
 - a. Refer to TSB110064 (New Two-Cylinder High-Pressure Fuel Pump Assembly) if replacing a three-cylinder two-piston pump with a two-cylinder pump.
 - b. New fuel lines are required if replacing a fuel pump gear pump with bottom mount fuel lines. Refer to TSB130044 (New Fuel Pump Gear Pump with Revised Fuel Line Locations).
2. Change the engine lubricating oil and lubricating oil filter. [Refer to Procedure 007-013 in the Associated Procedures Table.](#)

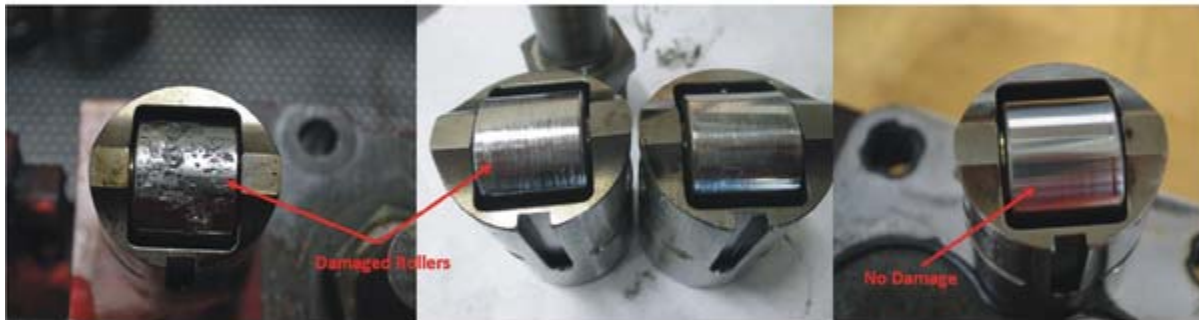
04v00002

Figure 2: Fuel Pump Tappet Roller Assemblies

If the fuel pump tappet rollers are damaged (see Figure 2), perform the following steps for the appropriate engine (ISX15 CM2250 or QSX15 CM2250 ECF):

1. Replace the fuel pump. [Refer to Procedure 005-016 in the Associated Procedures Table.](#)
 - a. Reference TSB110064 (New Two-Cylinder High-Pressure Fuel Pump Assembly) if replacing a three-cylinder two-piston pump with a two-cylinder pump.
 - b. New fuel lines are required if replacing a fuel pump gear pump with bottom mount fuel lines. Reference TSB130044 (New Fuel Pump Gear Pump with Revised Fuel

Line Locations).

2. Drain the engine lubricating oil and remove the lubricating oil filter. Refer to Procedure 007-013 in the Associated Procedures Table.
3. Thoroughly clean the oil cooler housing. Refer to Procedure 007-003 in the Associated Procedures Table.

4. Replace the lubricating oil cooler element. Refer to Procedure 007-003 in the Associated Procedures Table.
5. Replace the oil filter bypass valve. Refer to Procedure 007-014 in the Associated Procedures Table.

6. Replace the lubricating oil thermostat. Refer to Procedure 007-039 in the Associated Procedures Table.
7. Install a new lubricating oil filter. Refer to Procedure 007-013 in the Associated Procedure Table.

8. Fill the engine with new lubricating oil.
9. Perform an aftertreatment diesel particulate filter regeneration. Refer to Procedure 014-013 in the Associated Procedures Table.

10. Perform a second lubricating oil and lubricating oil filter change. Refer to Procedure 007-013 in the Associated Procedures Table.
