Technical Service Bulletin Number	Revision Level	Date	Group Number
TSB130017

ISX12 CM2350 X102 and ISX15 CM2350 X101 - Missing OEM Fuse Causing Diesel Exhaust Fluid (DEF) Line Heater Fault Code 3258 in PACCAR™ Chassis (Peterbilt™ 579 and Kenworth™ T680)

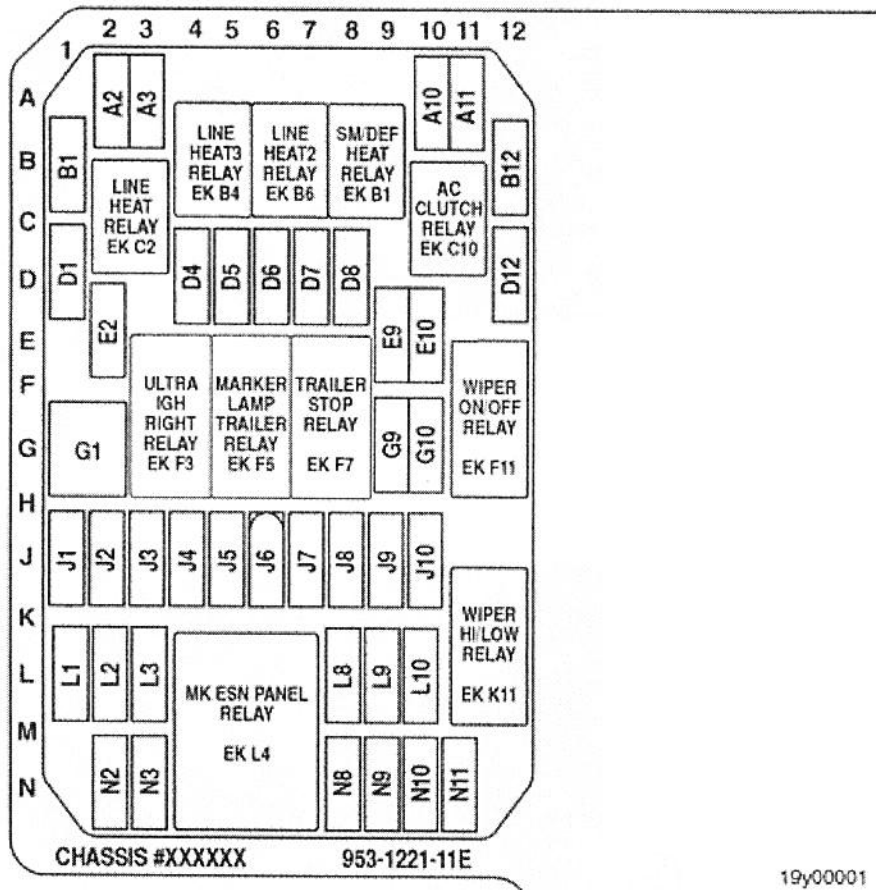
19y00001

The fuse that powers the DEF line heater relay was **not** installed on some ISX12 CM2350 X102 and ISX15 CM2350 X101 PACCAR™ trucks. The fuse panel label does **not** specify a fuse is needed in the required terminal.

Inspect the "L10" location in the fuse panel for a fuse. Units built without the fuse for the DEF line heater relay will have active Fault Code 3258.

Contact the original equipment manufacturer (OEM) for repair direction.
