| TSB130033 | | | |

## Technical Service Bulletin

Engine Ignition Coil Broken at the Spark Plug End for ISL G CM2180, C Gas Plus and L Gas Plus CM556, and C8.3G CM420 Engines

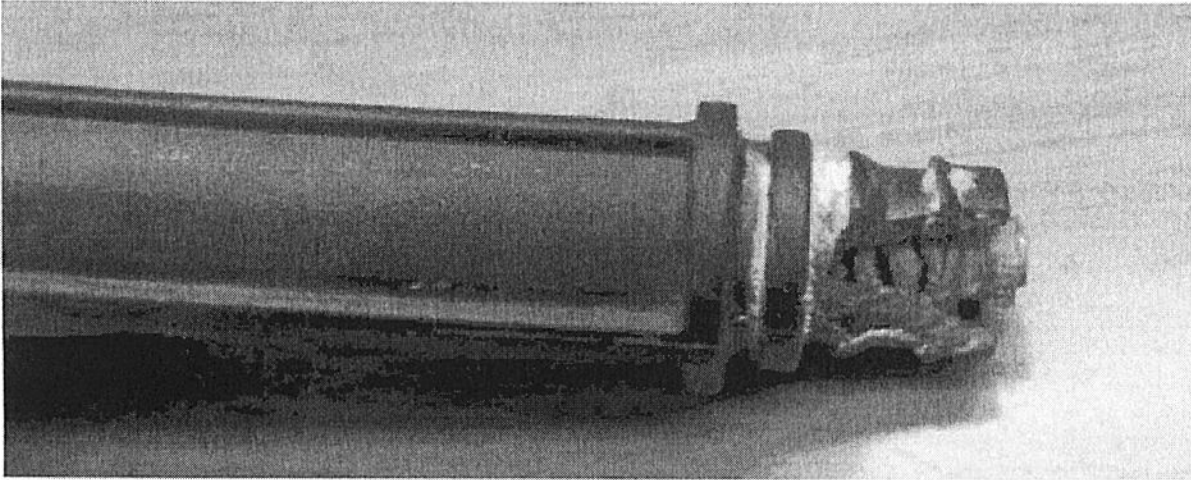
06300020

A misfire occurs due to an ignition coil extension broken at the spark plug end.

Root Cause: Inadequate clearance between the ignition coil extension and the spark plug ceramic allows removal/installation of the ignition coils while attached to the bracket.

Ignition coil extension broken at spark plug end.

**NOTE:** Do not remove the entire bracket with the coils attached.

Use the following procedure for proper coil removal. Refer to Procedure 013-012 in Section 13.

The manufacturing sub-assembly fixture/process was modified to position the ignition coils at the top of the slots in the coil bracket, Part Number 3933087.

Ignition coils on engines built before First ESN 73481931, date 12/07/2012, should be repositioned at the top of the slots in the coil bracket when being replaced/repared.
