Technical Service Bulletin Number TSB130113	Revision Level	Date	Group Number
--	----------------	------	--------------

ISX12 CM2350 X102 and ISX15 CM2350 X101 Fault Code 4585 After Calibration

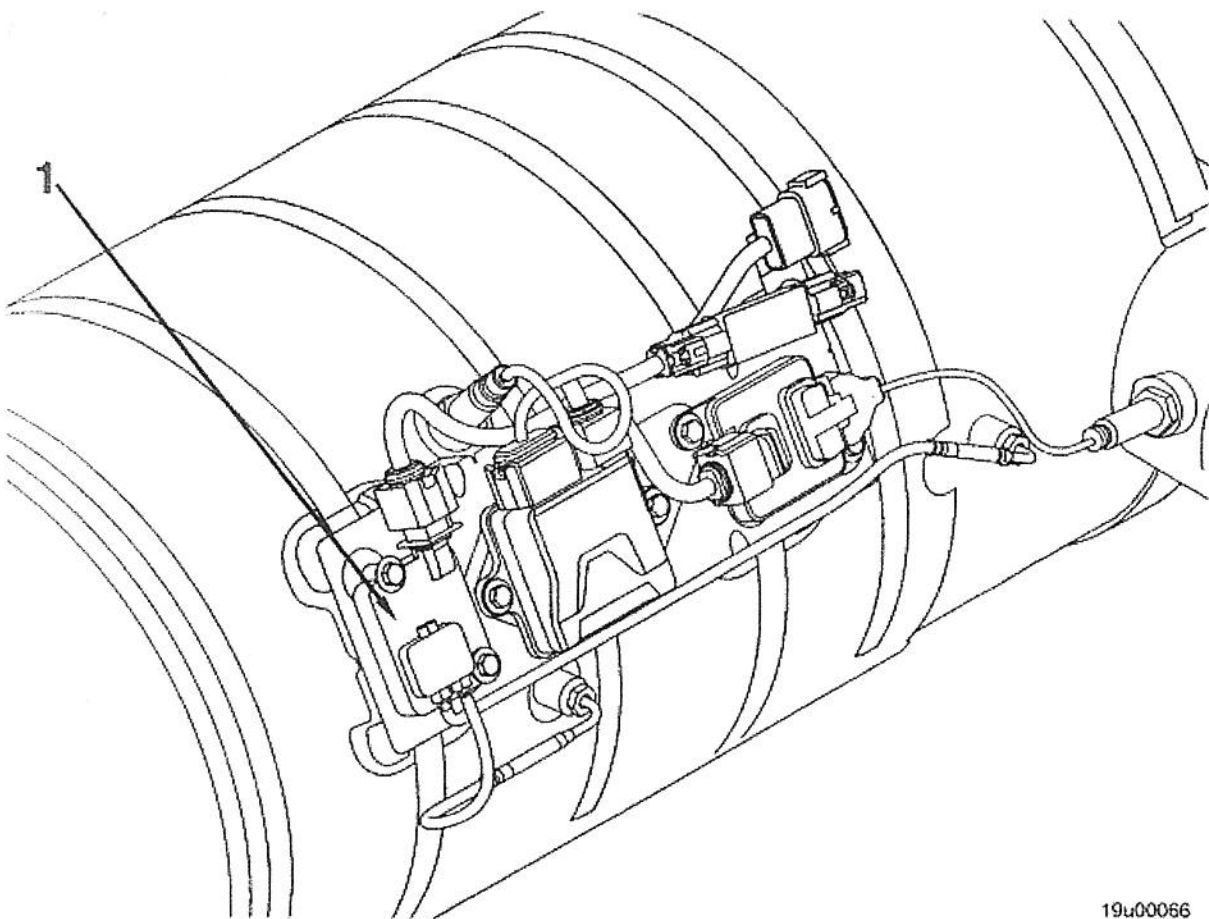
19u00066

NOTE: This is the same part number that is currently on the module. The aftertreatment SCR temperature sensor module (1) is shown below:

To clear the active Fault Code 4585, a new aftertreatment SCR temperature sensor module, Part Number 4307100, **must** be installed.
