| TSB120300 | | | |

## Technical Service Bulletin

Chirping Noise Heard From Primary Belt Drive on ISX12/11.9 and QSX11.9 CM2250 Engines

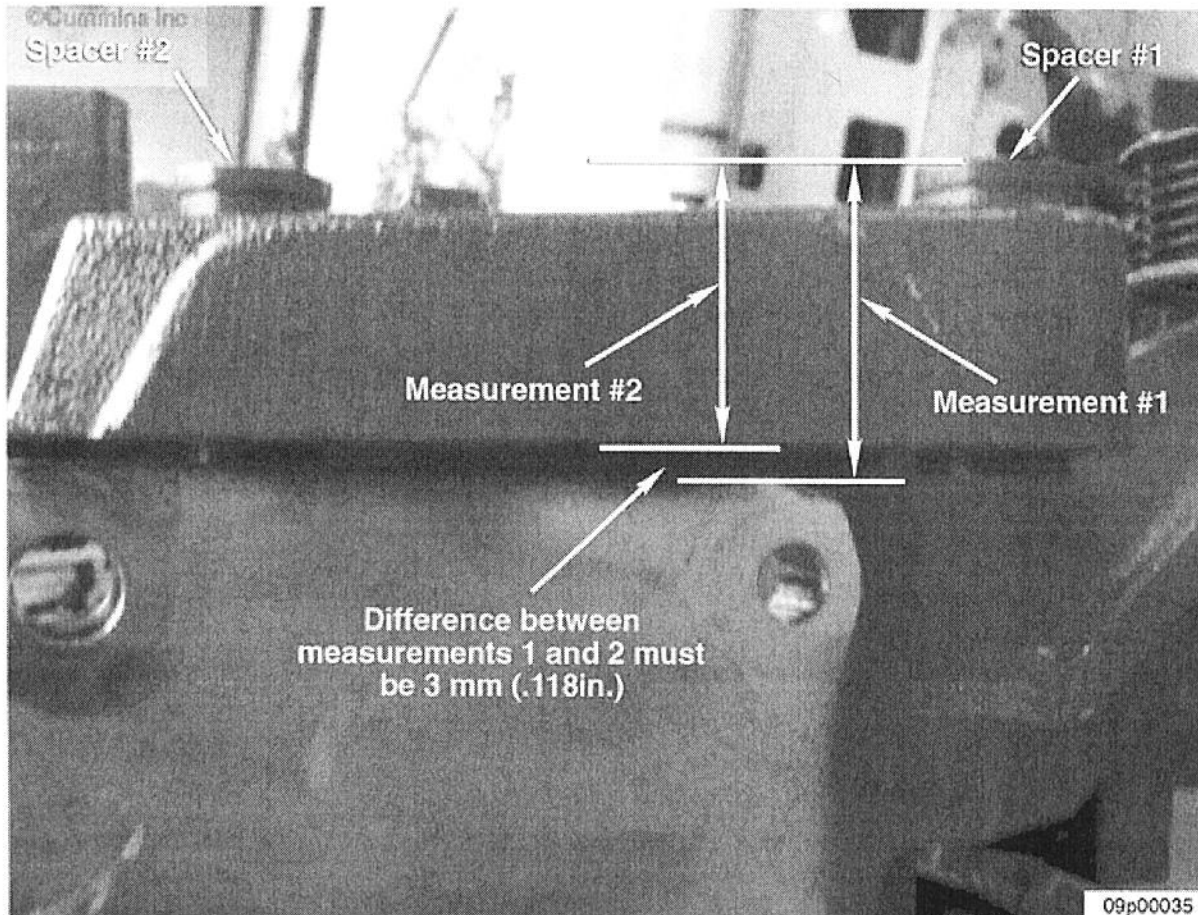
Figure 1: Front Mounting Capscrew Spacer Measurements

Primary belt noise, described as a chirping noise, is being heard at the water pump. The water pump and crankshaft pulleys are aligned with each other, but the belt tensioner between the two pulleys is tilted due to the way the refrigerant compressor/alternator bracket is mounted. This tilting causes a belt entry angle into the water pump that is susceptible to causing noise on the front end drive.

Perform the below measurements on Spacer 1 and Spacer 2, as shown in Figure 1, using a pair of dial calipers. These spacers are located at Capscrew 1 and Capscrew 2, as shown in

1. Measure the spacer installed in the bracket.
2. Measure from the front of the spacer to the underside of the bracket.

The difference between measurements 1 and 2 must be 3.0 mm [0.118 in]. If either spacer is not in the correct position, use a plastic hammer, or equivalent, to move the spacer. The differences between measurements 1 and 2 for both spacers need to be within 0.1 mm [0.0039 in] of each other to avoid tilt in the bracket. Reference Figure 1.
