TSB150153
-----------

Fault Code 3314, 3317, 3319, 3146 or 4518 Caused by Aftertreatment Exhaust Gas Temperature Sensor Malfunction

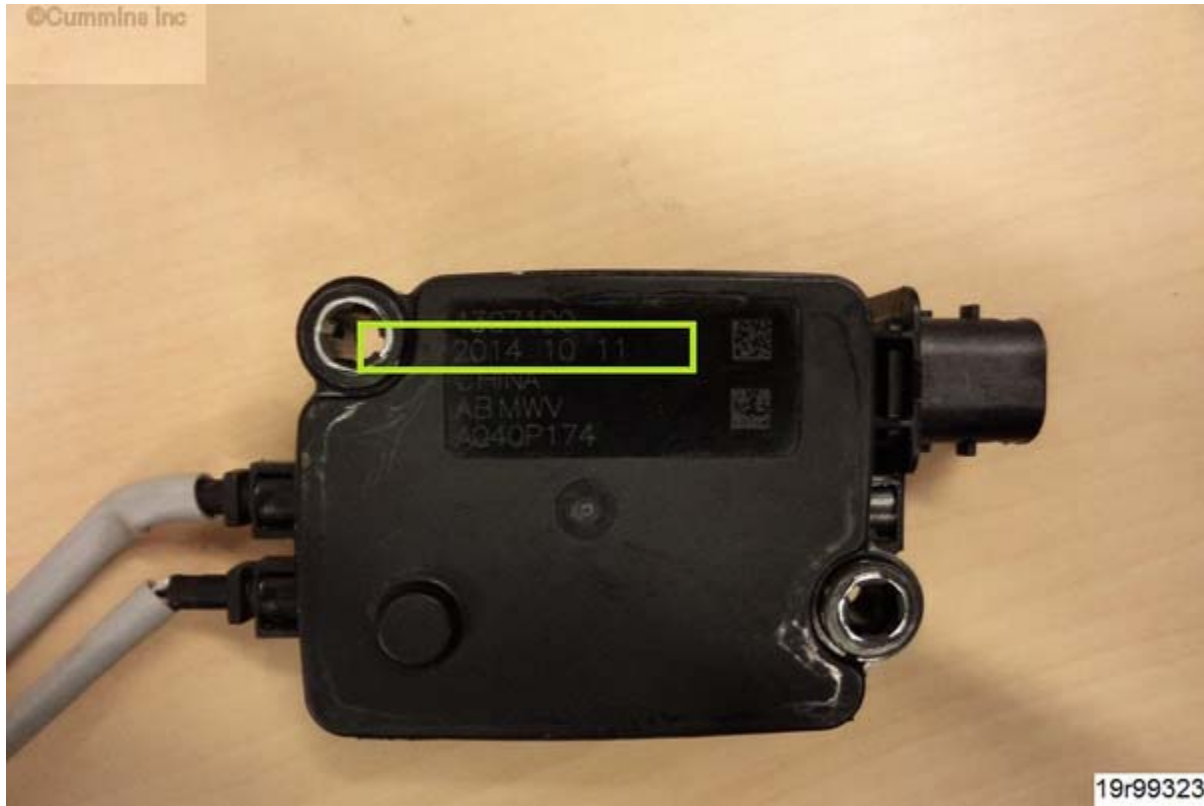
Figure 1, Date Code Location on the Aftertreatment Exhaust Gas Temperature Sensor.

If the aftertreatment SCR exhaust gas temperature sensor or the aftertreatment DPF exhaust gas temperature sensor requires replacement, the new aftertreatment exhaust gas temperature sensor **must** be inspected prior to installation. See Table 1 below.

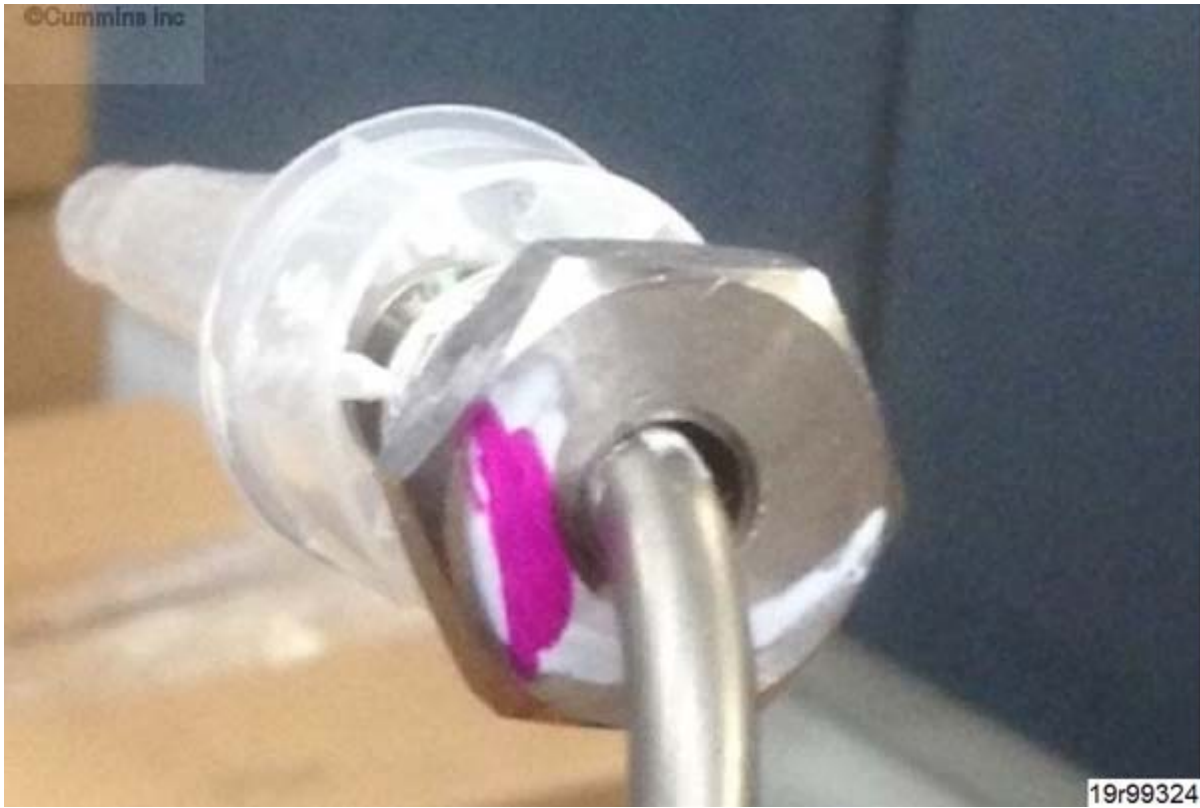
Figure 2, Marking on the Hexagon Nuts.

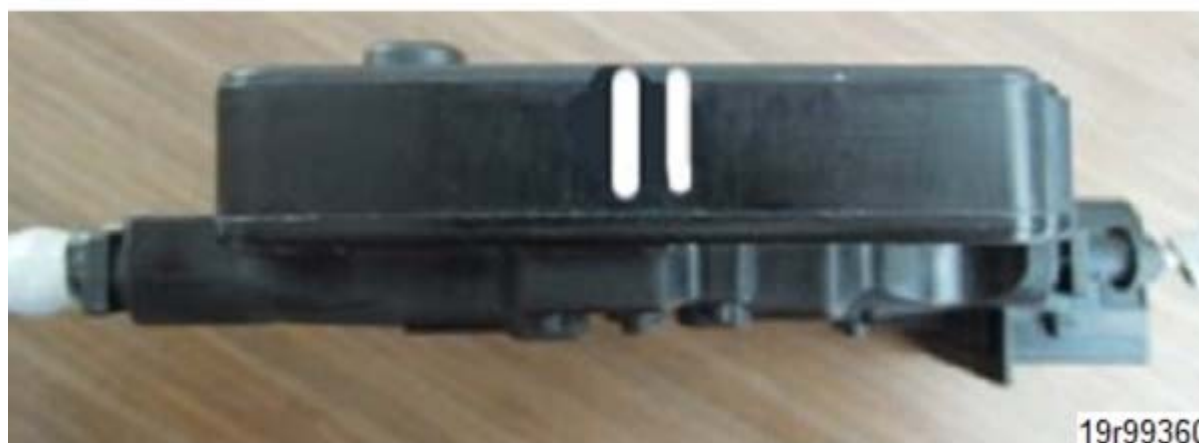
Figure 3, Marking on Exhaust Gas Temperature Sensor Body.
