TSB160093
-----------

Aftertreatment Intake NOx Sensor Malfunction and Incorrect Engine Control Module (ECM) Calibration Tuning Resulting in Fault Code 3748

- ISX12 CM2350 X102
- ISX15 CM2350 X101

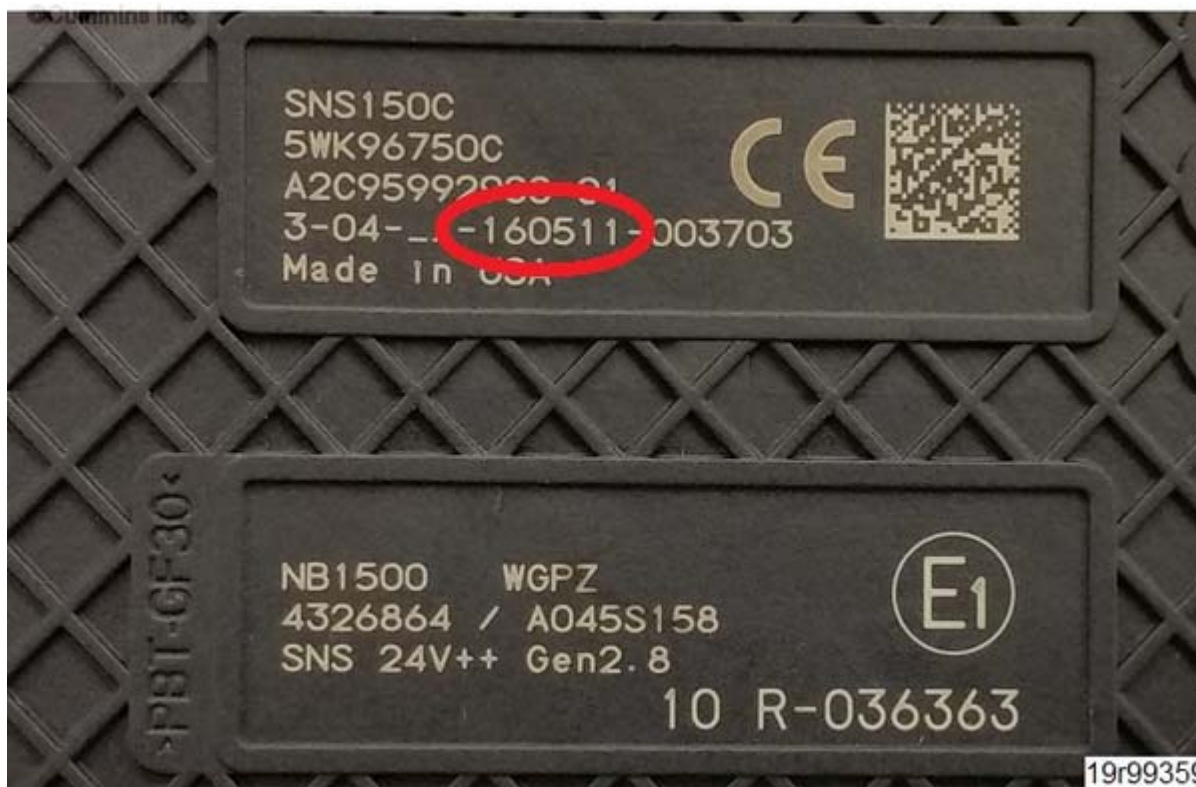
- Aftertreatment intake NOx sensor internal heater degradation.

- Verify build date of aftertreatment intake NOx sensor. See Figure 1 below for

aftertreatment intake NOx sensor build date location.

- If build date of aftertreatment intake NOx sensor is prior to August 2014, see Resolution section below.

Figure 1, Aftertreatment Intake NOx Sensor Base Plate with Build Date (YYMMDD) Highlighted.

- If aftertreatment intake NOx sensor has a build date prior to August 2014, replace the aftertreatment intake NOx sensor. See the corresponding Service Manual. Reference Procedure 019-463 in Section 19.
- If ECM calibration code has a revision date prior to August 2016, calibrate ECM. See the corresponding Service Manual. Reference Procedure 019-032 in Section 19.
