TSB150153

Fault Code 3314, 3317, 3319, 3146 or 4518 Caused by Aftertreatment Exhaust Gas Temperature Sensor Malfunction

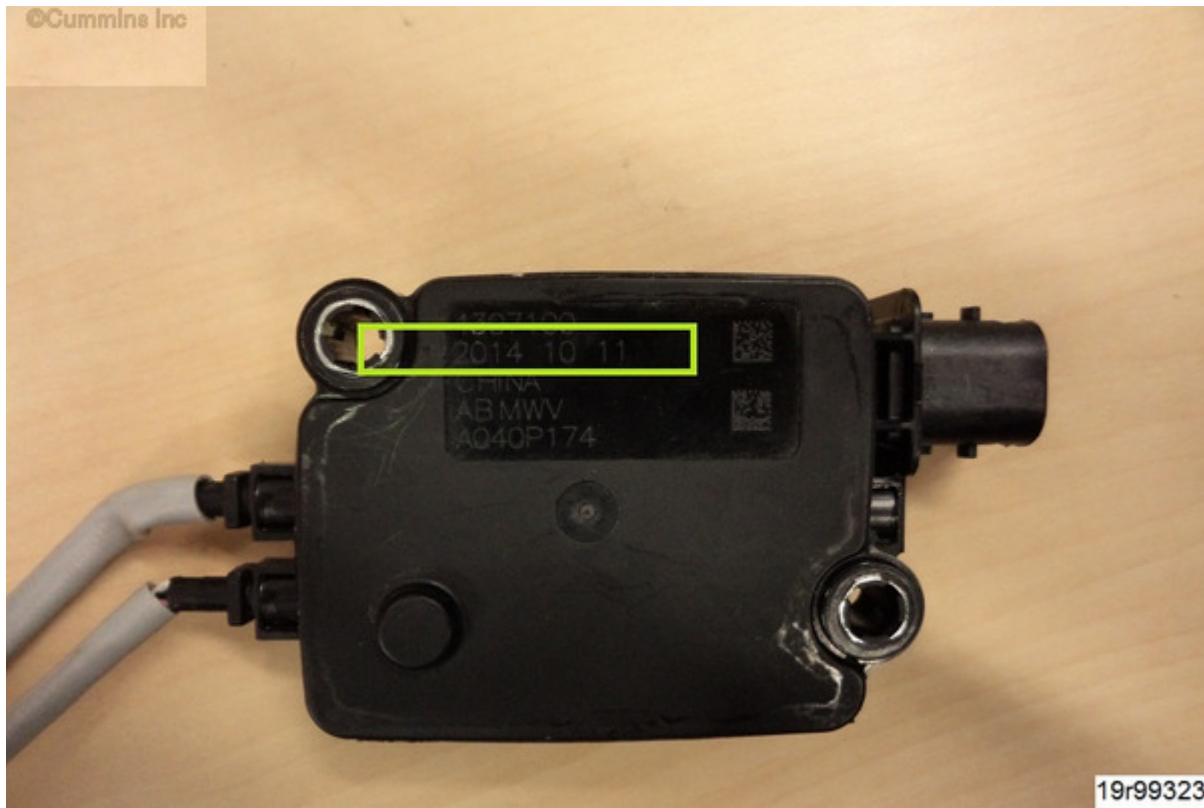
Figure 1, Date Code Location on the Aftertreatment Exhaust Gas Temperature Sensor

Table 1, Aftertreatment Exhaust Gas Temperature Sensor Inspection Criteria			
Part	Date Code On Sensor Body ¹	Marking on Hexagon Nuts ²	Action
Aftertreatment Exhaust Gas Temperature Sensor	20150730 and before	No marking	Do not use
	20150730 and before	White half circle and a pink line	OK for use
	20150731 and after	No marking or two parallel white bars	OK for use
¹ See Figure 1 Below. ² See Figure 2 Below.

If the aftertreatment SCR exhaust gas temperature sensor or the aftertreatment DPF exhaust gas temperature sensor requires replacement, the new aftertreatment exhaust gas temperature sensor **must** be inspected prior to installation. See Table 1 below.
