TSB140120

Technical Service Bulletin

Fault Codes Caused by Insulation Buildup on the Aftertreatment Diesel Particulate Filter (DPF) Inlet Face.

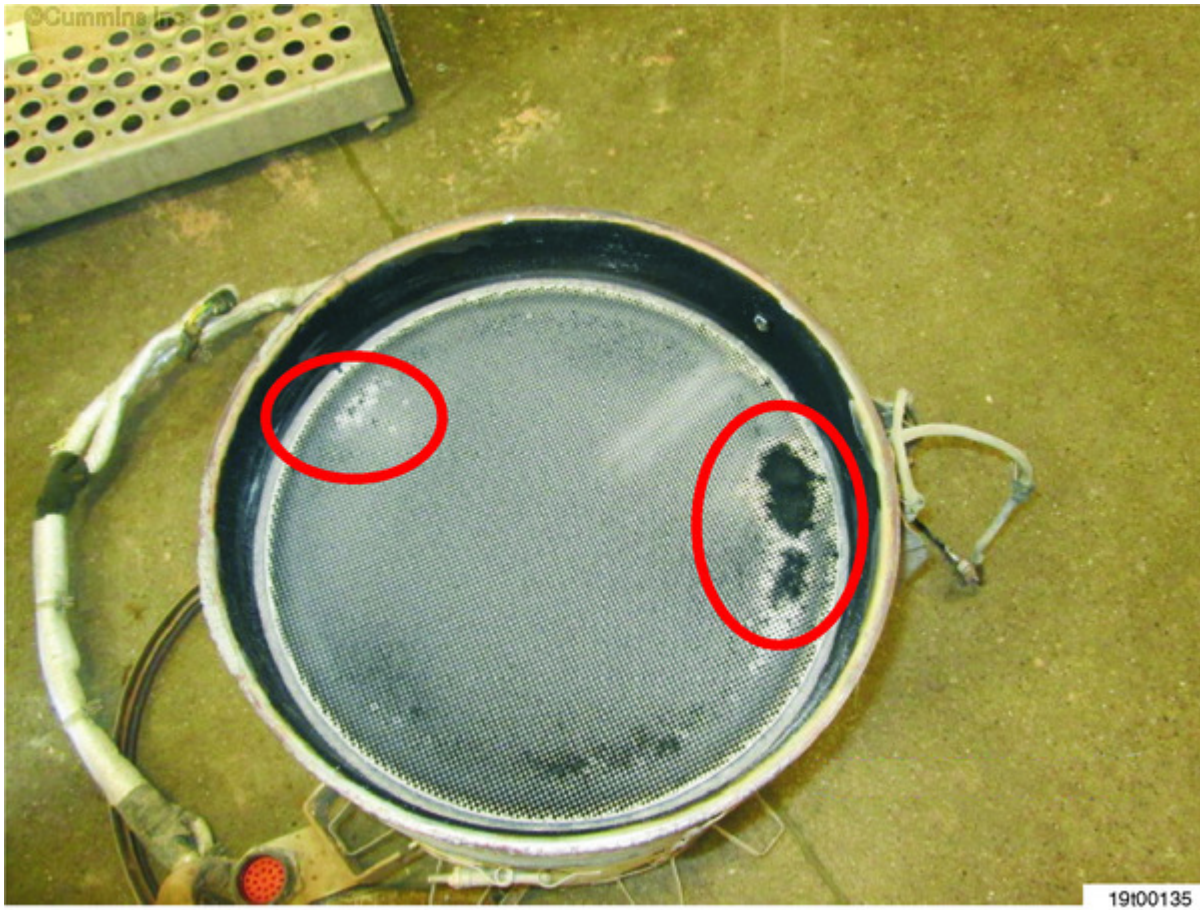
Figure 1

The insulation collects near the aftertreatment DPF intake temperature sensor port, plugging the aftertreatment DPF inlet face. See Figures 1 and 2 below.

1. If insulation buildup is present on the aftertreatment DPF inlet face and the aftertreatment system is equipped with one of the aftertreatment DOC part numbers listed in Table 1, perform the following:

- Clean the aftertreatment DPF.
- Use the following procedure in the ISX12 CM2350 X102 Service Manual, Bulletin 4310646. [Refer to Procedure 011-041 in Section 11](#)
- Use the following procedure in the ISX15 CM2350 X101 Service Manual, Bulletin 4310641. [Refer to Procedure 011-041 in Section 11.](#)
- Remove and replace the aftertreatment DOC.
- Use the following procedure in the ISX12 CM2350 X102 Service Manual, Bulletin 4310646. [Refer to Procedure 011-049 in Section 11.](#)
- Use the following procedure in the ISX15 CM2350 X101 Service Manual, Bulletin 4310641. [Refer to Procedure 011-049 in Section 11.](#)
- Clean the aftertreatment DPF intake temperature sensor probe.
