Technical Journal

XC90 T8 with unusual noise from ABS and BCM-C002201

REF NO: TJ 31473.3.0	ISSUING DEPARTMENT: Technical Service	CAR MARKET: United States and Canada	
PARTNER: 3 US 7510 Volvo Car USA		ISSUE DATE: 2016-09-06	STATUS DATE: 2016-09-09
FUNC GROUP: 5214	FUNC DESC: Brake servo, complete	Page 1 of 3

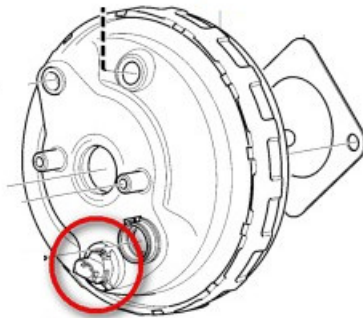
Make the brake booster accessible and locate the connector to brake booster solenoid 8/46, see picture TJ 31473.jpg

1. Disconnect the connector and check that all terminals in connector and in booster solenoid are dry and clean, if necessary clean terminals and dry up with high pressure air.
Note: replace complete booster if the male terminals have damages on the tin plating, PN 31400315 (follow VIDA VCC-ID: VCC-370759-14 for LHD cars).
Note: replace female terminals in the connector if the terminals have damages on the tin plating, PN 30656680.
2. Reinstall the connector to the brake booster and make sure that the cable harness is routed in the same way as picture TJ 31473 -2.jpg.
Reinstall all previously removed components (wiper mechanism, battery cable etc).
3. Clear DTC's using VIDA and release the vehicle if the DTC's does not reoccur.
Note: In case the DTC BCM-C002201 can not be cleared or if there is a repeat repair, send a Vehicle Report using sub concern area "Support not needed", f.gr 5900.

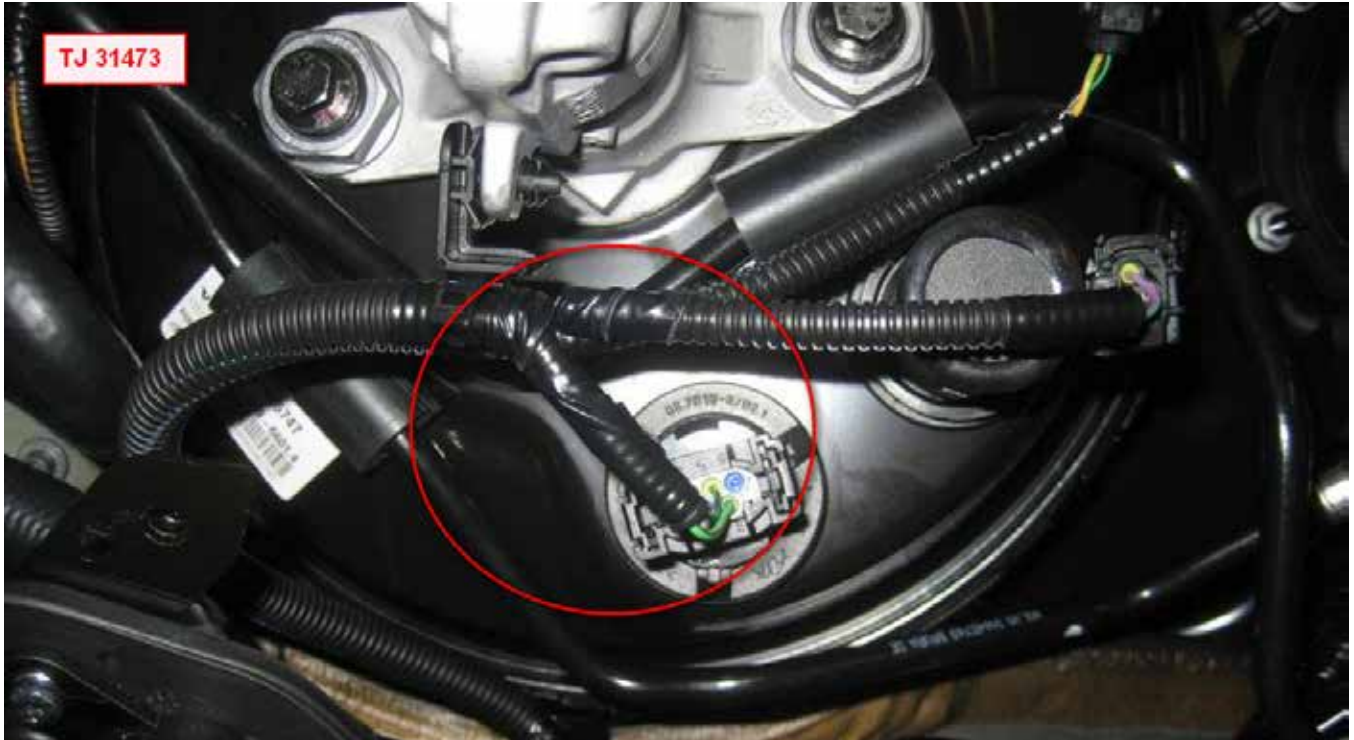
Production has changed the routing of the cable harness to the brake booster solenoid starting from chassis number 92921.
