TSB150068

Fault Code 2722 Due to Low Pressure Regulator Housing Casting Defect

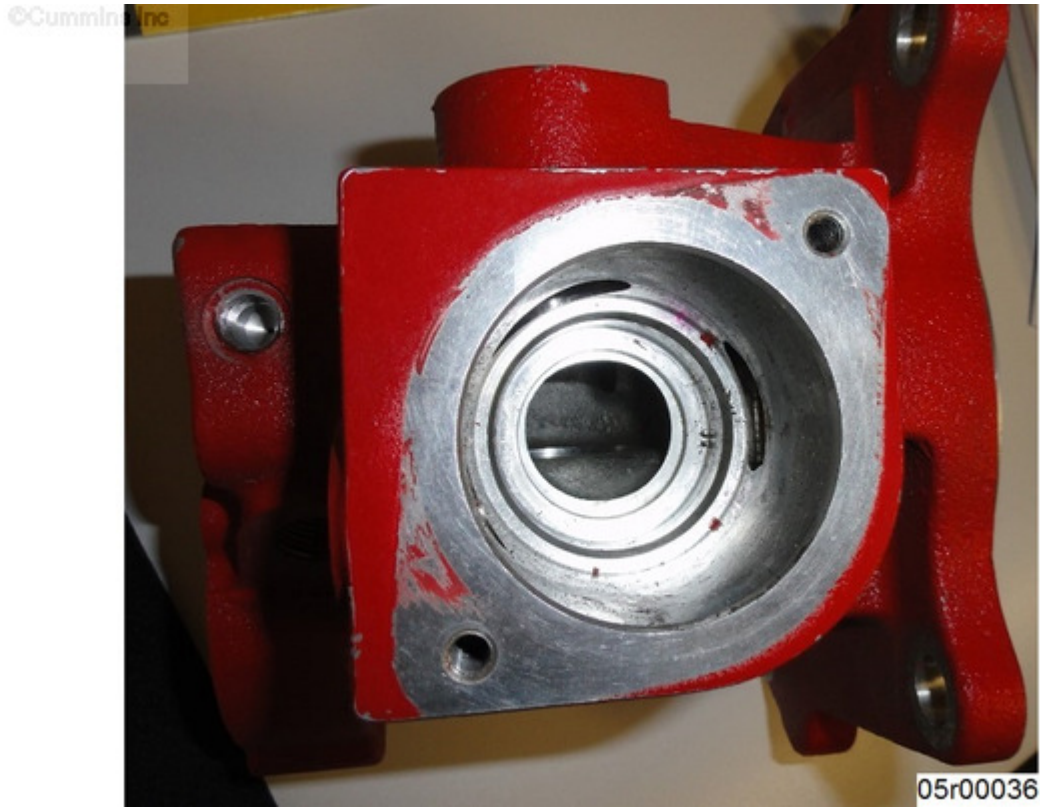
Inspect the low pressure regulator bore in the low pressure regulator housing for signs of

pitting. The pitting may appear to be dirt or debris, but can **not** be cleaned from the low pressure regulator bore. See Figures 2 through 4.

Figure 2, Low Pressure Regulator Bore with Pitting

If pitting is found, replace the low pressure regulator housing. Use the following procedure in the ISX12 G CM2180 EJ Service Manual, Bulletin 4310682. [Refer to Procedure 005-238 in Section 5.](#)

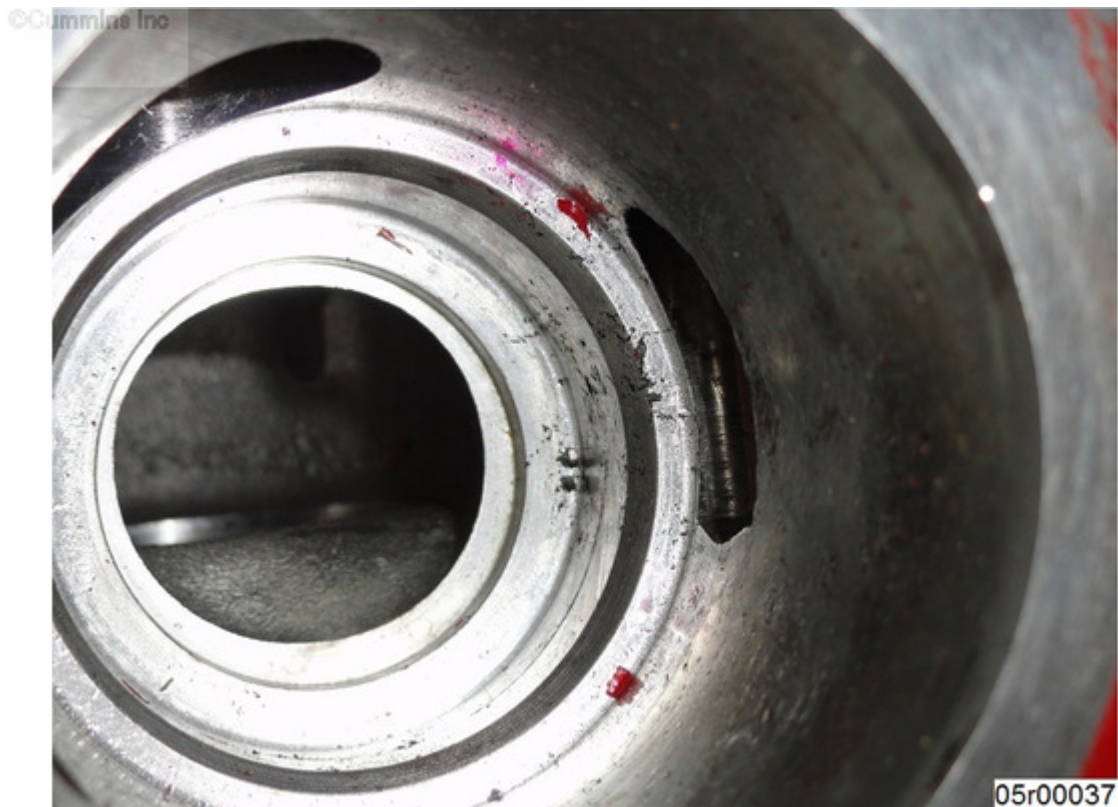
Figure 3, Low Pressure Regulator Bore with Pitting

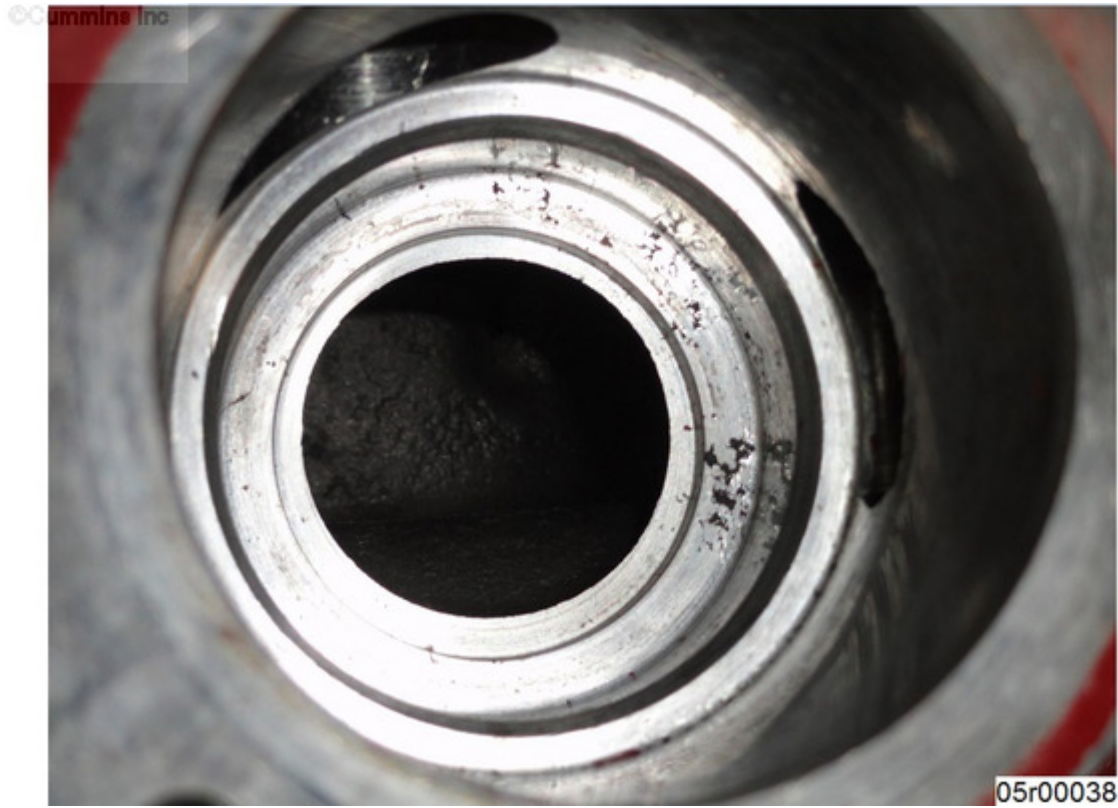
Figure 4, Low Pressure Regulator Bore with Pitting

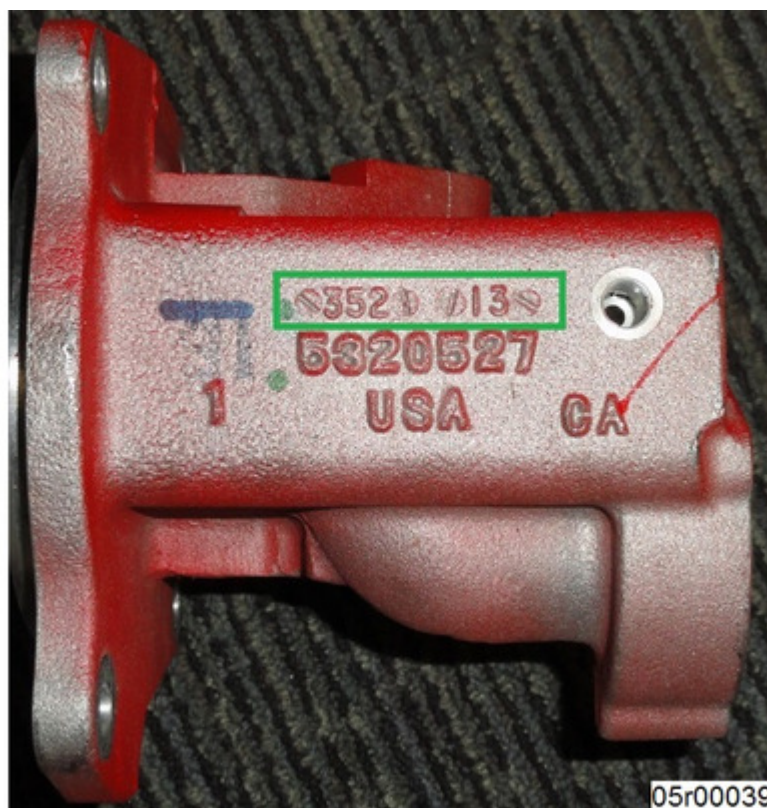
Figure 5, Low Pressure Regulator Date Code

Revisions to the low pressure regulator casting were implemented on 07 April 2014. Revision changes include adding material to the low pressure regulator casting prior to machining. Suspect low pressure regulator casting dates are prior to 097 14. Date code format is DDD YY. 097 14 is equivalent to the 97th day in 2014. See Figure 5.
